SERVICE BULLETIN

APPLICABILITY:	2013-14MY Legacy & Outback Models with 2.5L FB Engine		02-150-14R 02/07/14
SUBJECT:	Revised Valve Train Parts to Reduce a Warm Engine Tapping Sound from the Left Cylinder Head	REVISED:	03/3/14

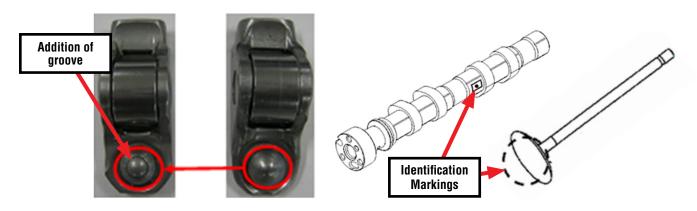
The illustrations below show additional information about the changes to the valve rockers, camshafts and valves to help readily distinguish them from the previous version parts.
