## SERVICE BULLETIN

**APPLICABILITY:** 2013-14MY Impreza 2.0L NA Models  
 2013-14MY XV Crosstrek, Including Hybrid Model (HEV)

**NUMBER:** 11-149-14R  
**DATE:** 11/06/14  
**REVISED:** 12/10/14

**SUBJECT:** Reprogramming File Availability for Oil Level Detection

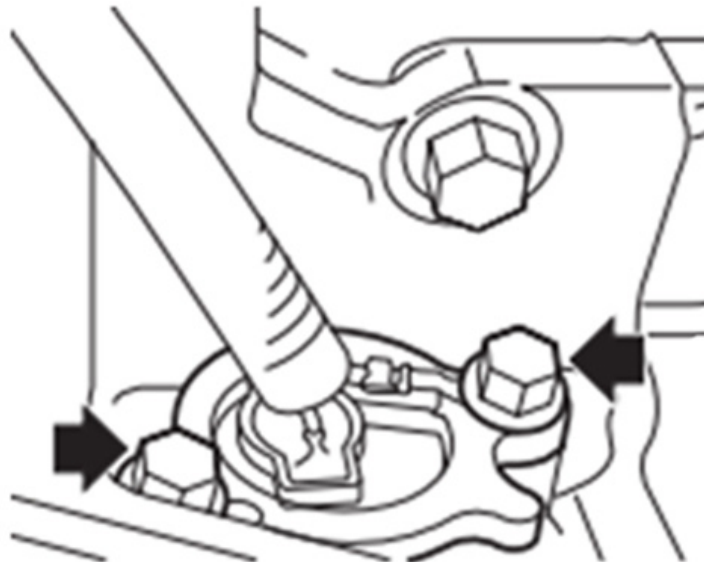
This bulletin announces the availability of reprogramming files and a revised oil level switch to optimize the ECM logic for engine oil level detection in the event of false or premature low engine oil level warning lamp illumination. Should a customer present a concern with a low engine oil warning lamp illumination and the diagnosis indicate the oil level is full or nearly full (oil level between the full and add marks/holes on the dipstick) and the customer has not added any engine oil, the ECM must be updated with this new logic and the oil level switch replaced. The new oil level switch part number supplied in this bulletin must be used. If the customer has added oil, determine how much was added. Based upon the information provided, estimate where the oil level was when the lamp illuminated in order to determine if additional action is required beyond what is described in this bulletin such as an oil consumption test. The ECM must still be updated with this new logic and the oil level switch replaced. The new oil level switch part number supplied in this bulletin must be used.

**Step 3** - Once the ECM reprogramming has been completed and the oil level switch wiring has been confirmed to be OK, proceed with replacing the oil level switch assembly shown in the illustration below following the procedure outlined in the applicable Service Manual. Torque the 2 retaining bolts to 6.4 Nm (56 inch-pounds). Torque the 2 retaining bolts to 6.4 Nm (56 inch-pounds).
