## SERVICE BULLETIN

**APPLICABILITY:** 2012 (AFTER VIN C\*411693)- 14 MY  
 Forester Models with 2.5L FB Engines

**NUMBER:** 02-144-13R

**SUBJECT:** Surface Treatment Change To Oil Control  
 Piston Rings

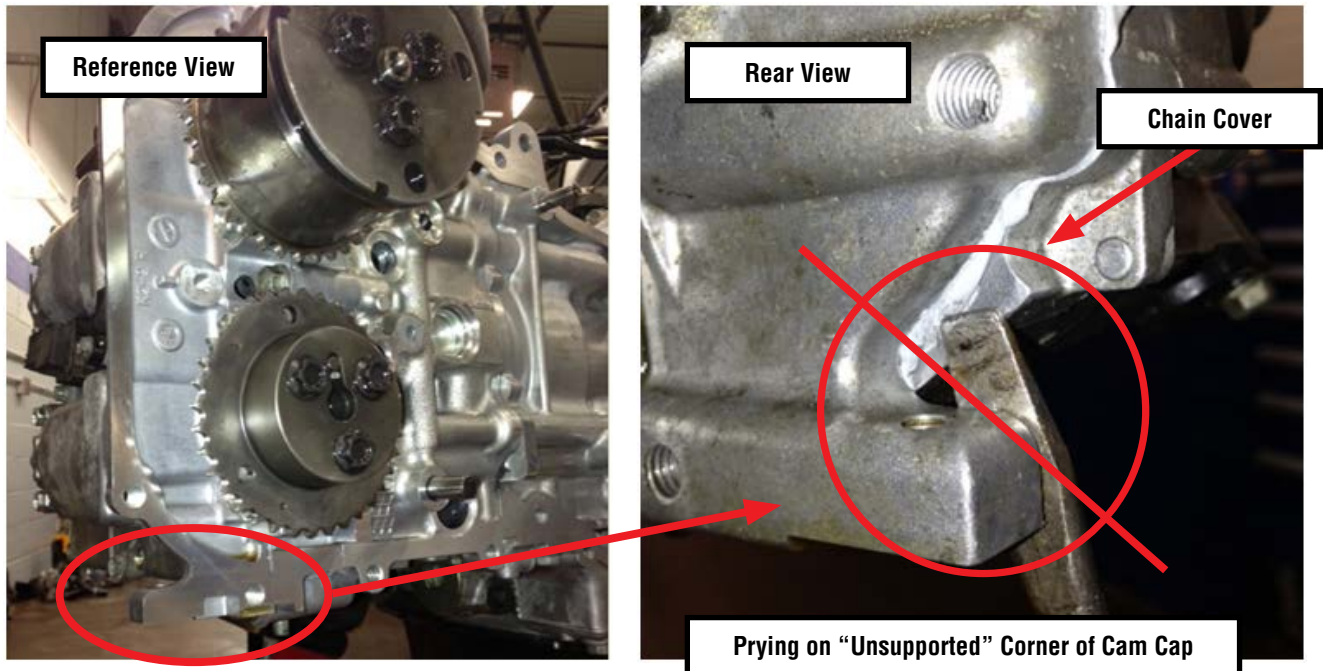
- **IMPORTANT:** After all 32 bolts securing the chain cover are removed, be **VERY** careful where you pry and what you pry on to break the silicone sealant bond. The photos below show an example of where NOT to pry. In this case, the cam cap became cracked requiring a complete cam carrier replacement. Patience is the key!
