SERVICE INFORMATION

APPLICABILITY: 2005-13MY Legacy and Outback Models with 5AT NUMBER: 16-91-14 2006-13MY Tribeca DATE: 01/29/14

SUBJECT: Correction to Diagnostics for 5AT-Related DTCs: P0743, 748, 753, 758, 763, 768 and 773

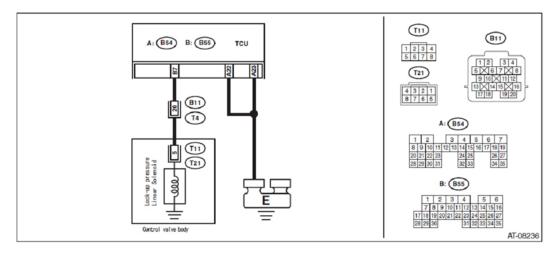
The connector number described above (T11) is the vehicle harness connector between the transmission control module and control valve body as shown in the schematic shown on pg. 2). The check is to measure the resistance between transmission ground and control valve body connector (T21), pin 5. Connector T11 should be labeled T21 (valve body harness connector).
