SERVICE BULLETIN

APPLICABILITY: 2010-2014MY Legacy & Outback Models **NUMBER:** 12-169-14
SUBJECT: “Click”, “Pop” or “Creek” Sound from Left or Right **DATE:** 07/10/14
 Outer Cowl Corner / Base of “A” Pillar Area

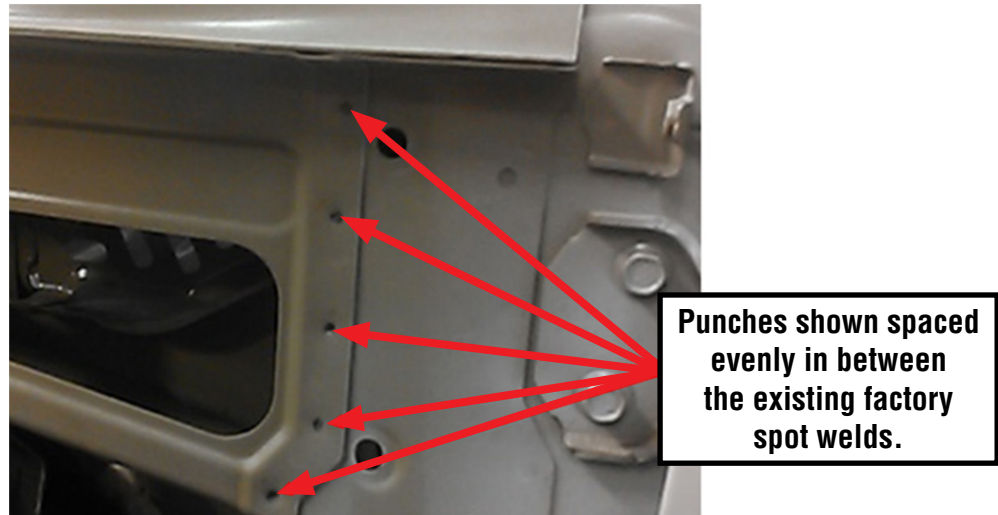
Once the sound has been confirmed and isolated to the area described in the introduction of this bulletin, the fender for the side of the vehicle in question will need to be removed following the procedure outlined in the applicable Service Manual. It may be necessary to use Chassis Ears to determine the precise source of the sound. The left fender is removed in the photo below.

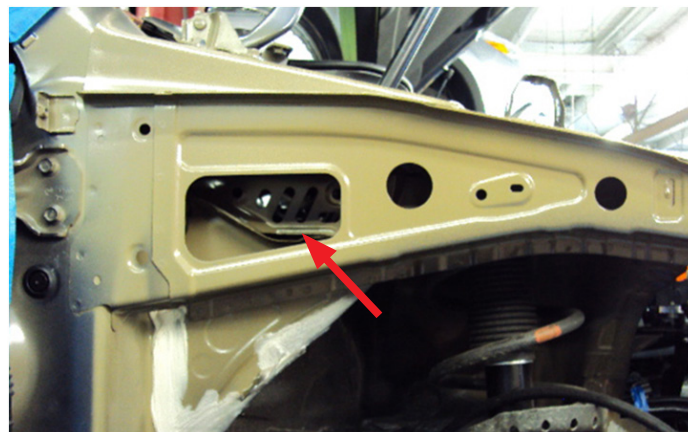
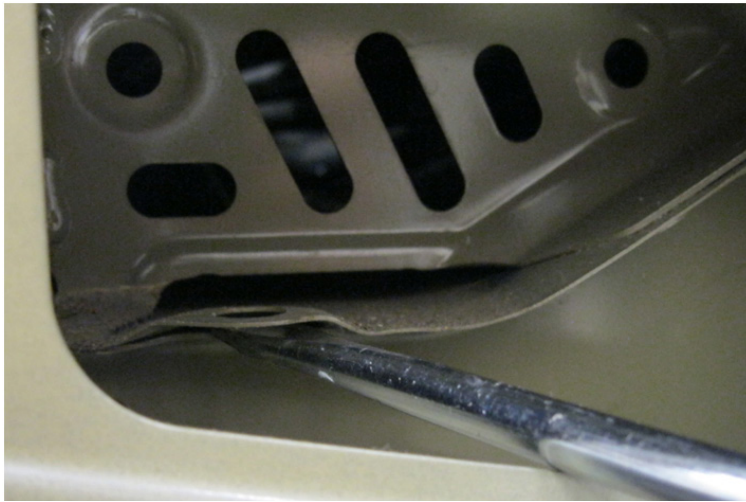
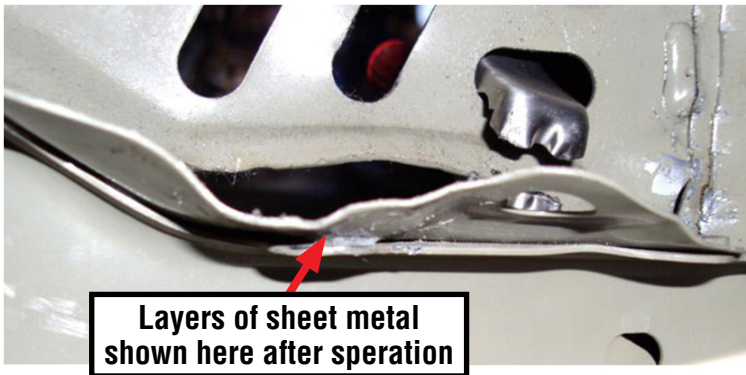
Another area which may be the source of these sounds is shown in the photos below. Although the right fender is removed in the photo, the structures are symmetrical side to side. Separate the layers of sheet metal using a flat-blade screwdriver but use caution not to tear or separate any spot welds.

- When these procedures are complete, always touch up, seam seal or undercoat any exposed bare metal areas to prevent rust from developing.
- Adding additional welds to the body structure is **NOT PERMITTED** as doing so may have an effect on the crash-worthiness of the vehicle.
