**SUBARU**

## SERVICE BULLETIN

**APPLICABILITY:** 2012 - 13MY Impreza Models with 2.0L FB Engines **NUMBER:** 02-145-13R  
 2013MY XV Crosstrek **DATE:** 09/25/13

**SUBJECT:** Surface Treatment Change To Oil Control  
 Piston Rings

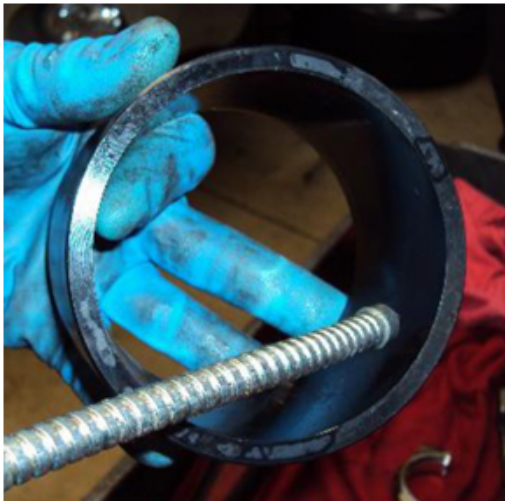
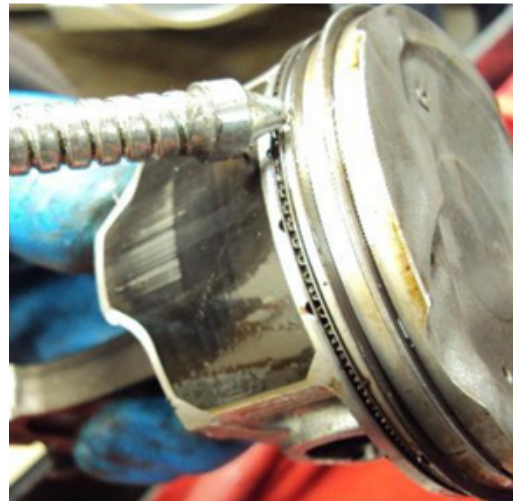
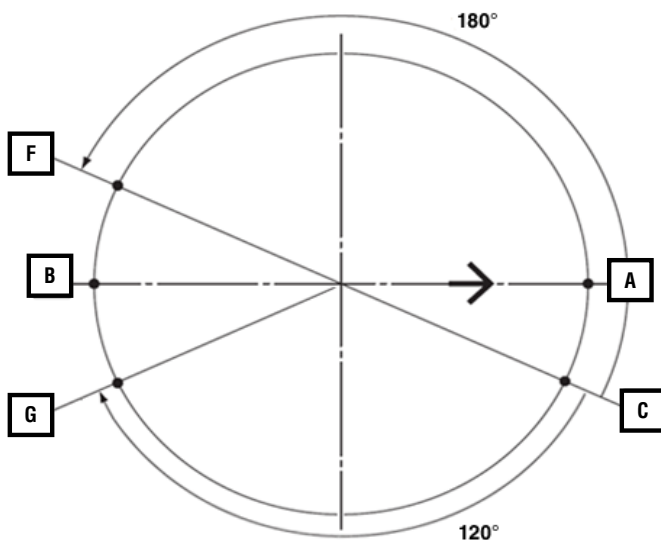
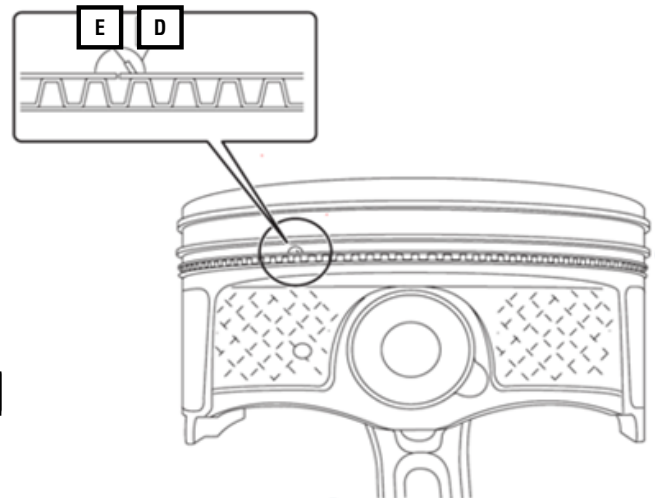
- "A"- Top compression ring end gap location
- "B"- Second compression ring end gap location (180 degrees away from "A")
- "C"- Top oil control scraper ring end gap
- "D"- Recess in top of ring land to accept the "tang" of the upper oil control scraper ring - "E"
- "F"- Expander gap (180 degrees away from "C")
- "G"- Bottom oil control scraper ring end gap (120 degrees away from "C")

- When cleaning the pistons prior to installing the new rings, take care not to damage the anti-friction coating applied to the skirts. A mild parts cleaner may also be used with the Scotch-Brite Ultra-Fine #7448 (gray in color) to loosen and remove carbon deposits from the piston crown and from between the ring lands. Do not use Scotch-Brite to clean the piston skirts as it can damage the anti-friction coating. The ends of a removed compression ring may be used to carefully clean deposits from inside the ring lands. Rinse the piston / rod assemblies thoroughly and dry before installing the new rings onto the pistons. Refer to the Service Manual and the illustrations below for ring direction (marks facing upward) and end gap placements before placing the piston/rod assembly into the ring compressor.

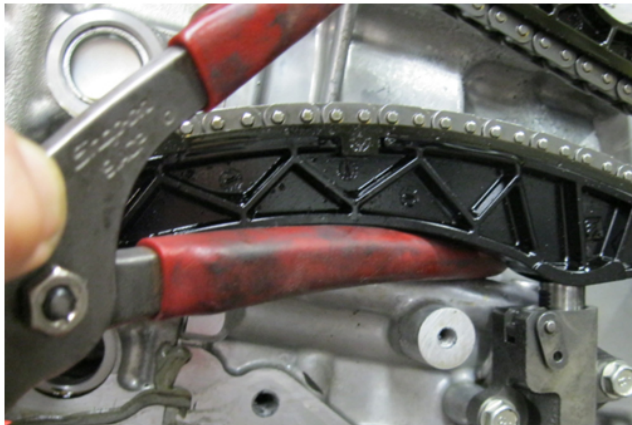
Rubber-coated plier handle inserted between a ledge area on the front of the block and the B1 lower chain guide **VERY CAREFULLY** lifting upward on the lower guide.

- Same as the left side, align the indicator links to the timing marks found on the cam sprocket assemblies. Install the chain guides and tensioner. Once proper positioning has been confirmed, pull the pin to release the tensioner. With your hand, grab and squeeze the upper and lower left side chain / guides together to allow the plunger in the tensioner to fully extend and click into its furthest notch as shown in the previous (right side) photo. If necessary, insert a rubber-coated plier handle between the ledge area on the front of the block and the right side (B1) lower chain guide. Then, **VERY CAREFULLY** lift up on the guide just enough to get the extra “click” on the tensioner as shown in the photo below.
