ARTICLES CONTAINED IN THIS ISSUE

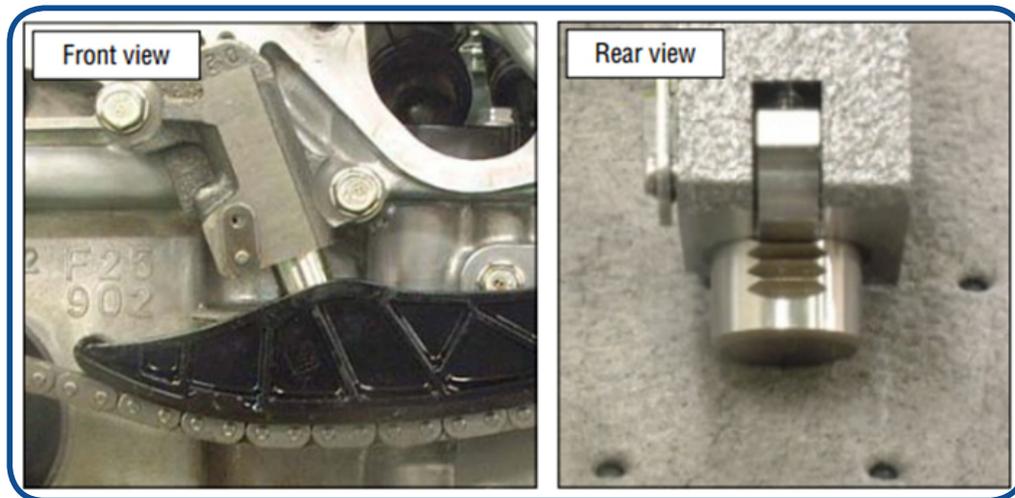
The Techline continues to receive calls regarding a cold engine tapping sound heard on initial start-up. In some cases, it is heard after engine repairs involving timing chain R&R are involved. In 2011, we released TSB# 02-113-11R on this subject. When reassembling the engine's timing chain components and performing the initial setting for of the chain tensioners, it is important to get that "extra click" out of BOTH tensioners as described below to minimize the chances of the cold engine sound reoccurring.

For example: If after timing component reassembly, you have 3 notches showing on the plunger, push down firmly on the upper chain guide to get the extra click so you end up having 4 notches showing. If you have 4 notches showing, you want to get the extra click to end up with 5. Whether you start with 3 notches or 4 showing depends on the amount of wear there is on the guides and timing chain.

- Use a small mechanic's mirror to help view the adjustment notches as they face the engine block and are difficult to see.

NOTE: It is **NOT RECOMMENDED** to use a pair of large channel lock-type pliers to squeeze the chain guides together and achieve the desired tensioner setting. Damage to the guides will likely result.

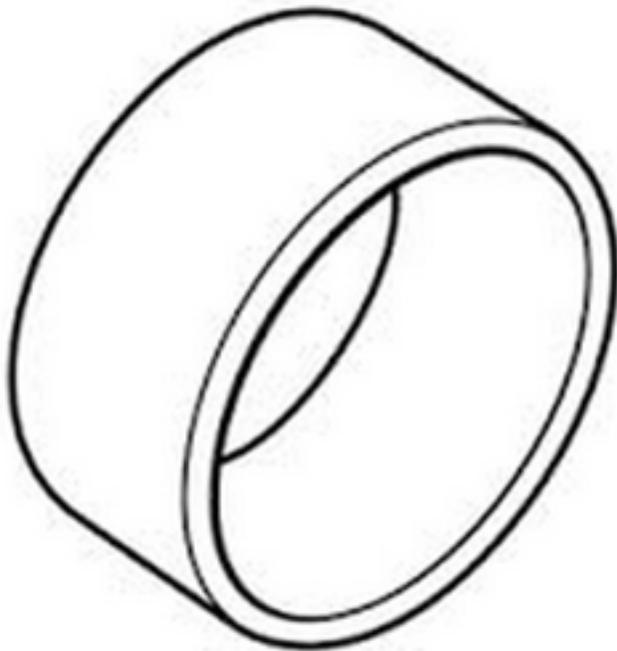
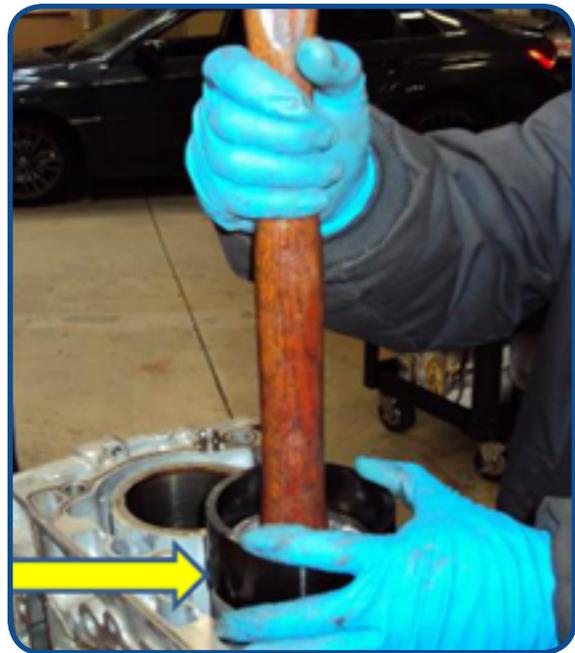
All three bulletins (02-143-13R, 02-144-13R and 02-145-13R) recommend the use of the factory tapered or non-adjustable - type piston ring compressor, J-50553 for 2.5L FB engines and J-50984 for 2.0L FA engines as illustrated below.

This type of piston ring compressor takes the guesswork out of whether the rings are compressed sufficiently to enter the cylinder. This can be difficult to determine when using an adjustable band - type compressor resulting in a grip that may be too tight or too loose on the piston assembly. It also provides the best “seal” to the block deck surface when installing the piston assembly into the bore and minimizes the chance of oil scraper rings popping out from between the ring compressor and the block deck surface. It is important to always hold the compressor firmly on the block surface as shown in the above, right photo. Use one firm, direct motion for the actual piston assembly insertion. If an oil scraper ring is displaced during engine assembly, severe piston and cylinder wall damage will result. At that point, the need for a short block replacement is virtually guaranteed. The photos below illustrate damage that occurred when an improperly installed oil control ring went undetected during engine reassembly. Always turn the engine over after each piston assembly is installed and develop a “feel” for how much turning effort is required. If it doesn’t “feel” right and seems to take more effort than normal, a loose / bent over scraper ring might just be the cause. In addition, check for any unusual vertical markings on the cylinder walls after rotating the crankshaft by hand. The photo at the top of page five (5), on the left, shows an upper oil scraper ring bent over and on the right, the resultant damage to the cylinder wall after the engine was taken apart again because of persistent, unusual oil consumption.

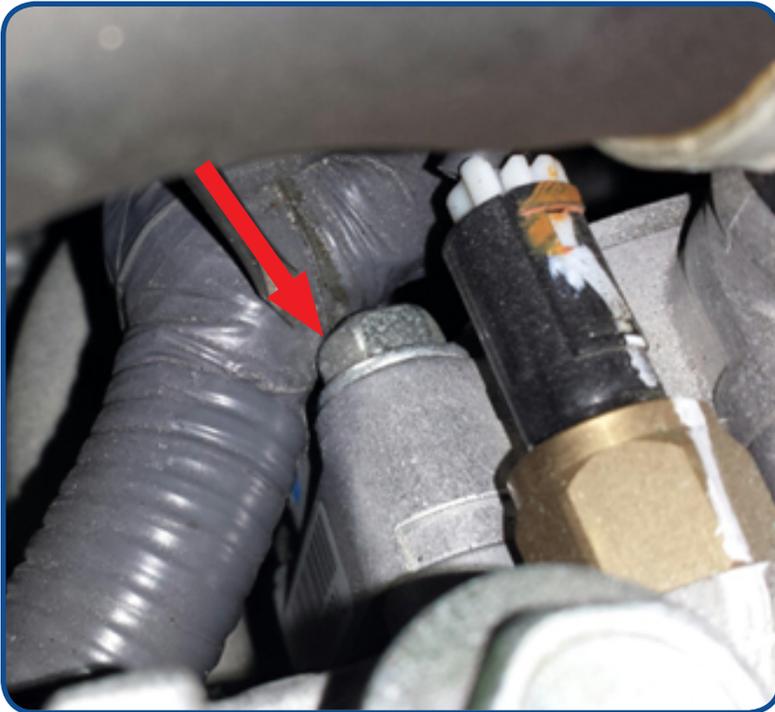
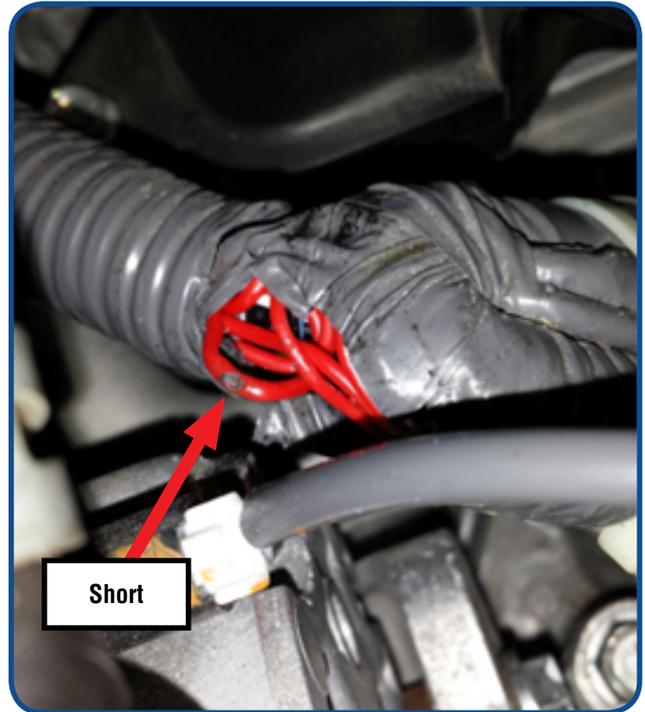
If you encounter a vehicle with electrical concerns and find fuse #16 in the under-hood fuse box (M/B) failed, inspect the engine wiring harness in the area of the power steering pump mounting bolt closest to the pressure switch for chafing or rub-through. The photos below show the area to inspect and damage to the harness which resulted in a short to ground and the root cause for the open fuse #16. This information applies to both H4 and H6 models.

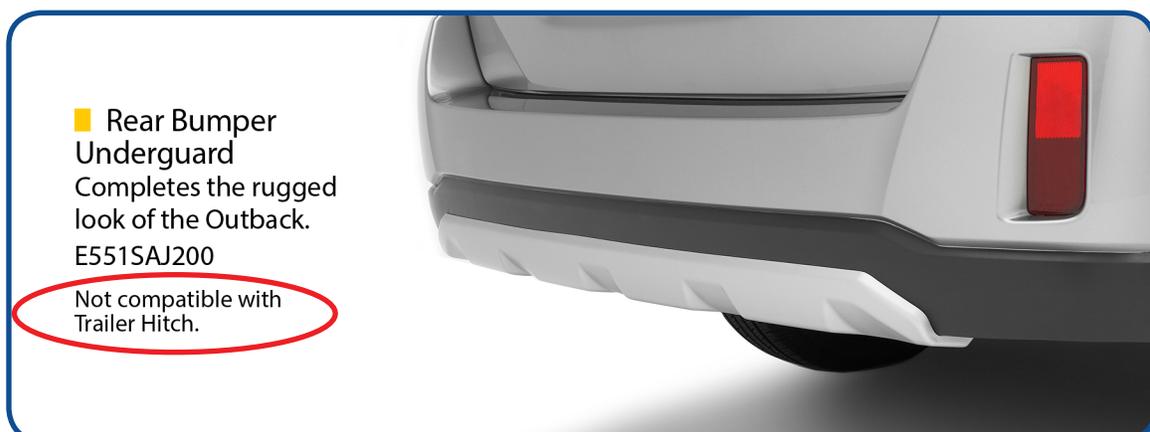
As per the Outback accessory brochure, when accessorizing a 2010-2014MY Outback, the Rear Bumper Underguard accessory, E551SAJ200 is not compatible with the L101SAJ001 Trailer Hitch accessory as shown below.
