SERVICE BULLETIN

APPLICABILITY: 2014MY XV Crosstrek Hybrid (HEV)

NUMBER: 07-87-14

SUBJECT: Design Change of Rear Combination Lamps to Prevent Fogging and Condensation

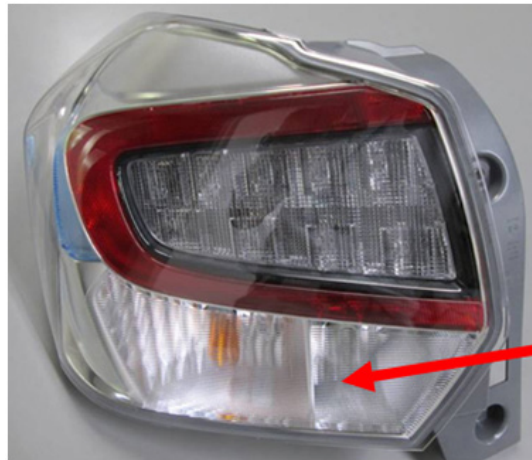
Anti-Fog coating applied on the inner surface of the outer lens.

- An Anti-Fog coating is now applied during production to the inner surface of the outer lens.

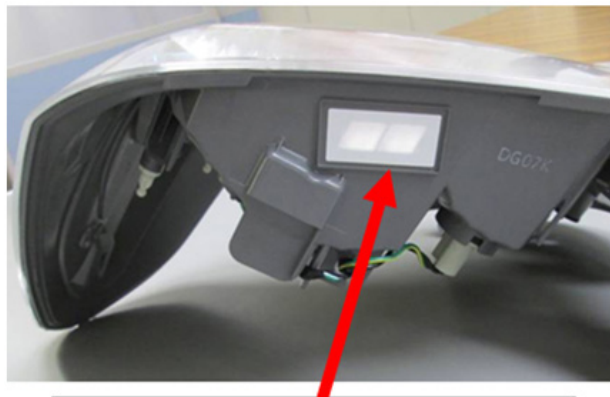
Additional ventilation added.

- Additional ventilation added to the bottom portion of the housing.

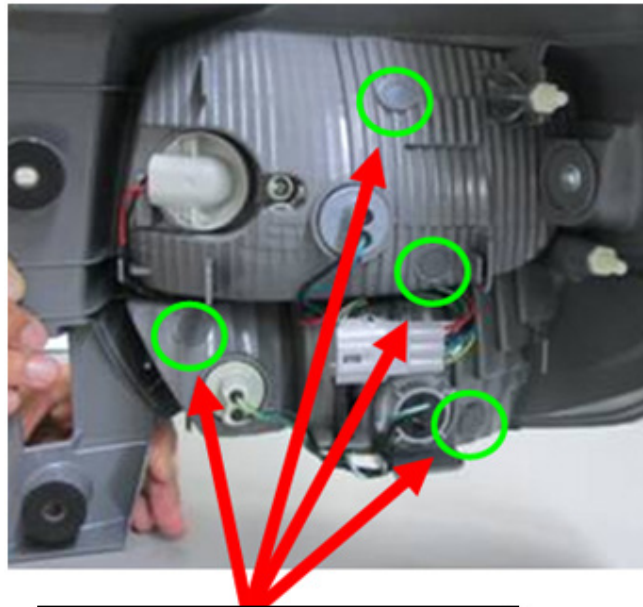
Shape and locations of 4 ventilation holes changed.

- Revised shape and locations for the 4 existing ventilation holes.
