**SERVICE BULLETIN**

**APPLICABILITY:** 2015MY WRX Models with 2.0L DIT Engine      **NUMBER:** 09-59-14  
**SUBJECT:** Rust Treatment Procedure for Heat Shield Retaining Bolt Heads      **DATE:** 11/18/14

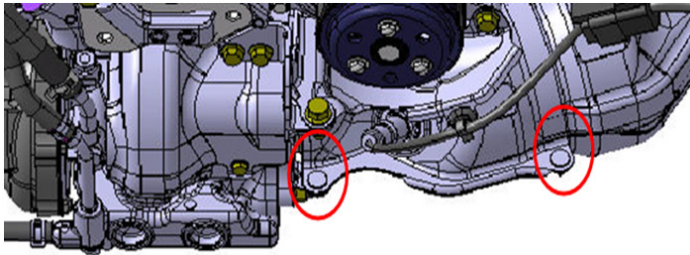
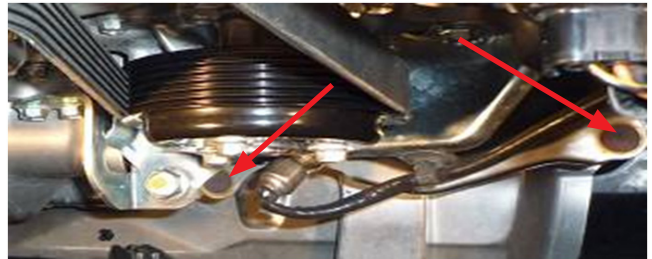
This bulletin provides a treatment procedure to address a customer concern of rust developing on the front exhaust pipe heat shield retaining bolt heads as shown in the illustrations below.

The application of heat resistant anti-corrosion material was incorporated into production starting with VIN F\*813768.
