# Technical Bulletin

Model(s)	Year	Eng. Code	Trans. Code	VIN Range From	VIN Range To
Tiguan	2011-2015	All	All	All	All

40 14 04 June 24, 2014 2037509

Clicking or Popping Noise from the Front Suspension after a Change in Direction

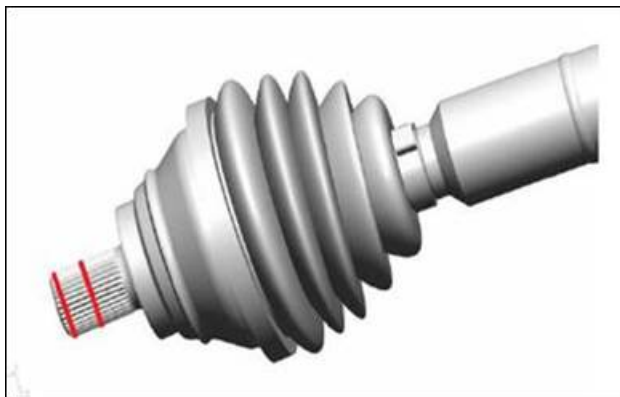
Figure 1

When accelerating after a change of direction (forward or reverse) a one-time clicking or popping noise occurs in the front left or front right of the vehicle.

The concern is due to the relative movement of the outward drive axle spline in the wheel bearing.

- Remove the drive axle from the affected side following the repair procedure outlined in ELSA Pro.
- Bond the outward splines of the drive axle with liquid locking compound (part number: D 000 600 A2) to the wheel bearings.

Use two continuous beads on the spline. The first bead should be applied at the beginning of the spline and the second should be in the center of the spline teeth (Figure 1, red marks).

- After applying the locking fluid to the spline reinstall the drive axle following the repair procedure outlined in ELSA web.

**Upon completion of the bonding procedure the vehicle must remain stationary for 1 hour.**
