Technical Bulletin

46 14 02 February 07, 2014 2015173 Supersedes T. B. V461303 dated May 22, 2013 to include 2014 model year applicability.

Brake Disc Pulsation or Vibration (U.S. Only)

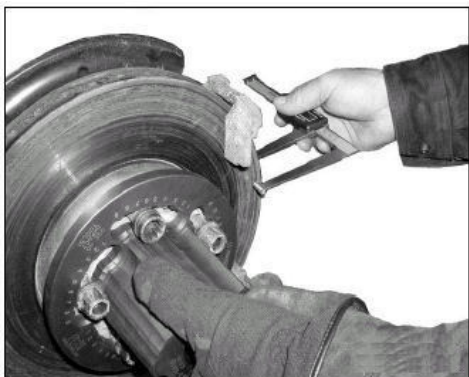
- Inspect brake disc friction surfaces on both sides of the brake disc for:
- Severe discoloration (bluing)
- High heat surface damage (raised hard spots)
- Visible cracks

Brake discs showing any of the above described conditions **MUST** be replaced.

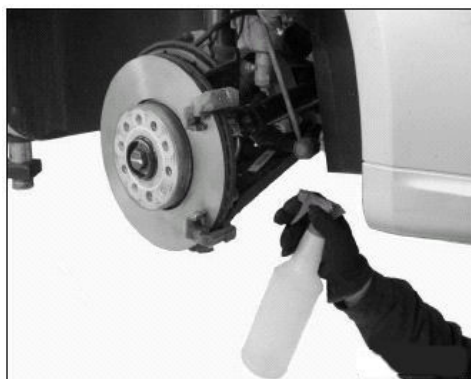
Recommended on-car brake lathes are either the PRO-CUT International™ PFM 9.0, or the Hunter Engineering Company model OCL 400. This design of brake lathe will produce a surface quality which will provide proper brake performance without a brake pad to brake disc break-in period.

To ensure that a high quality brake disc finish is produced, brake lathe cutting tools must be maintained as directed by the lathe or tool manufacturer.

- Follow the brake lathe manufacturer's instructions for set-up and machining.
- Wash the brake disc with a soap and water solution upon completion of resurfacing to remove all machining particles.

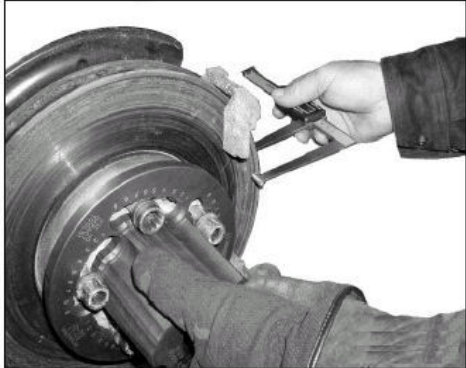
- Re-measure brake disc thickness in 4 locations using either the Pro Cut International™ disc thickness measuring tool Part No. 50-902 or the Hunter Engineering Company disc thickness measuring tool Part No. 25-99-2. If recorded brake disc measurement is less than the minimum thickness, the brake disc **MUST** be replaced.

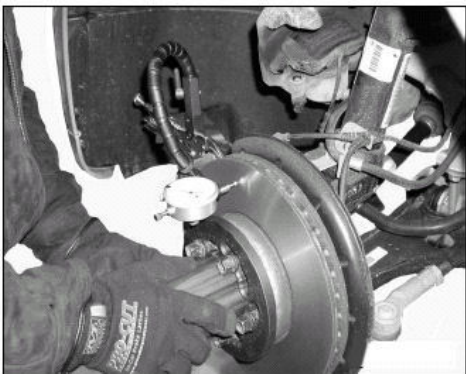
- Measure brake disc lateral run out using Pro Cut Disc Lateral run out measuring kit Part No. 50-700FC or the Hunter Disc Lateral run out measuring kit Part No. 25-128-2 with a dial indicator.
- Run out must not exceed 0.1mm.
- If brake disc exceed the 0.1mm specification replace the applicable brake discs.
