# Technical Bulletin

| Model(s) | Year | Eng. Code | Trans. Code | VIN Range From | VIN Range To |
|---|---|---|---|---|---|
| Jetta Wagon | 2001 – 2006 | All | All | All | All |

55 14 05 December 5, 2014 2038994

### Corrosion in Corner Area of Rear Lid towards Rear Lights

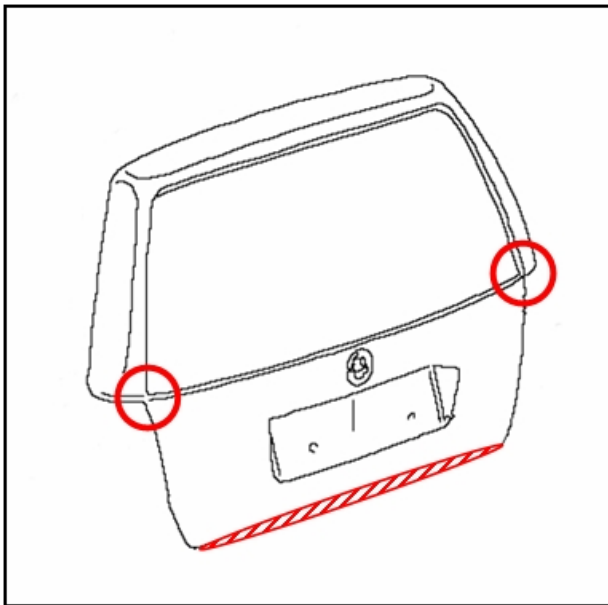
Corrosion in the corner area of the rear lid towards the rear lights (Figure 1).

**Figure 1 - Red circles - corrosion on the rear lid**

Hatch area - possible fold corrosion on the rear lid

- Insufficient fine seam sealing.
- Edges on the inner panel too sharp.
- Heavy load on corners by relative movement.

1. Replace the rear lid.

2. Repair the rear lid. Only perform this operation if the total repair cost is 80% or less of the total replacement cost.

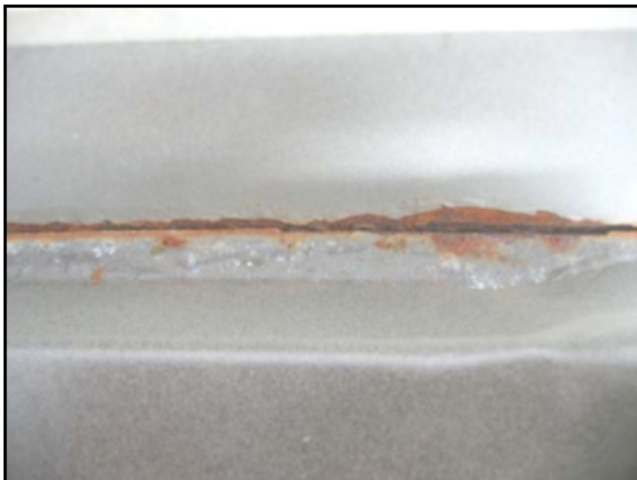
Figure 2

If the lower fold area of the inner rear lid exhibits through-corrosion (perforation) (see Figure 2), DO NOT repair, Install a new rear lid.

**Before the repair, check the fold area of the inner rear lid. If the lower fold area of the inner rear lid exhibits through-corrosion (perforation) (see Figure 2), DO NOT repair and install a new rear lid.**
