Technical Bulletin

Model(s)	Year	Eng. Code	Trans. Code	VIN Range From	VIN Range To
Jetta SportWagen	2009-2014	All	All	All	All

55 14 09 December 16, 2014 2038998

Corrosion on the Rear Lid around the License Plate Light

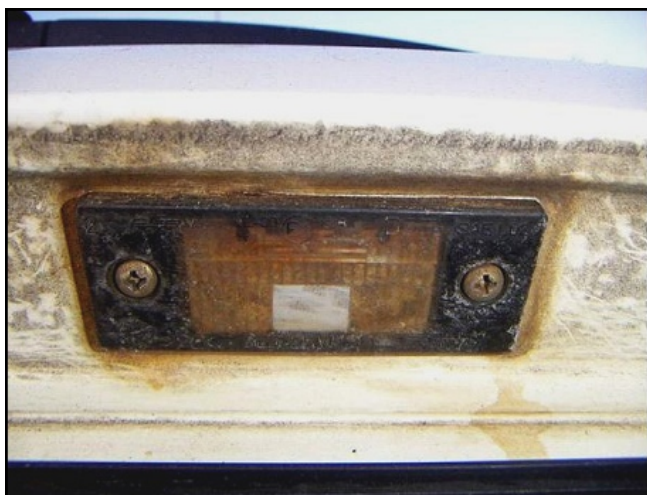
Edge corrosion on the rear lid around the license plate light (Figure 1 and 2).

Figure 1: corrosion on and around the license plate light - example 1K5, screw installation

Electrolytic corrosion around the license plate lights (opening/contact surface, inside and outside) because of water ingress via the seal of the license plate lights.

1a. Repair (Remove corrosion and restore paint structure).

1b. Replace the rear lid.

2. Seal off contact surface and screw holes of license plate lights with butyl sealing cord (part number: AKL 450 005 05)3. Replace the license plate lights - use part number with latest index.

4. Replace the seal for rear screen wiper shaft (part number 6Q6 955 758 A).

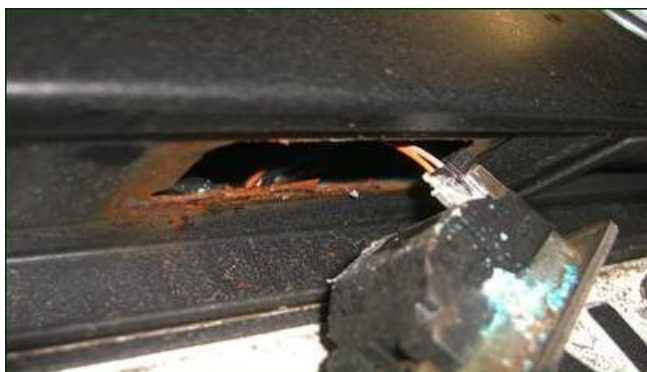
Figure 2: corrosion on opening for the number plate light - example AJ5, clipped installation

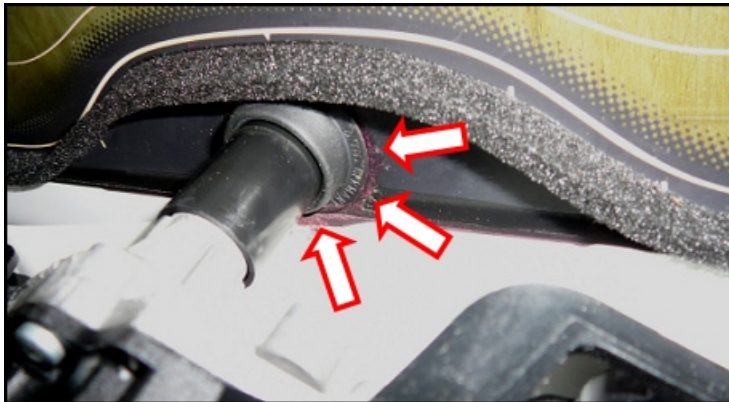
Figure 3

In rare cases the seal of the rear window wiper shaft can leak (Figure 3, red arrows) and water ingress is possible on the inside of the lift gate.

- Replace the seal for rear wiper shaft (part number 6Q6 955 758 A) according to the repair manual.
- Install all the removed parts according to the repair manual.

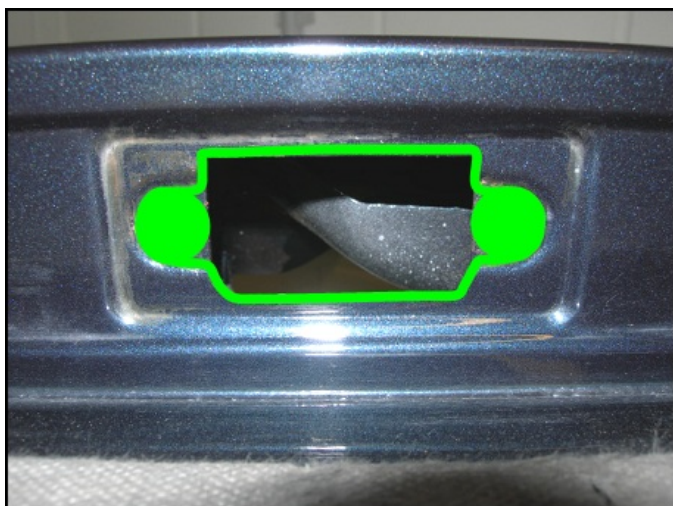
Figure 4) example 1K5 - License plate light, butyl sealing cord areas

- Apply butyl sealing cord (0.2 cm x 20 cm) on the contact surface and attachment area of the license plate lights (Figure 4 and 5 in green).

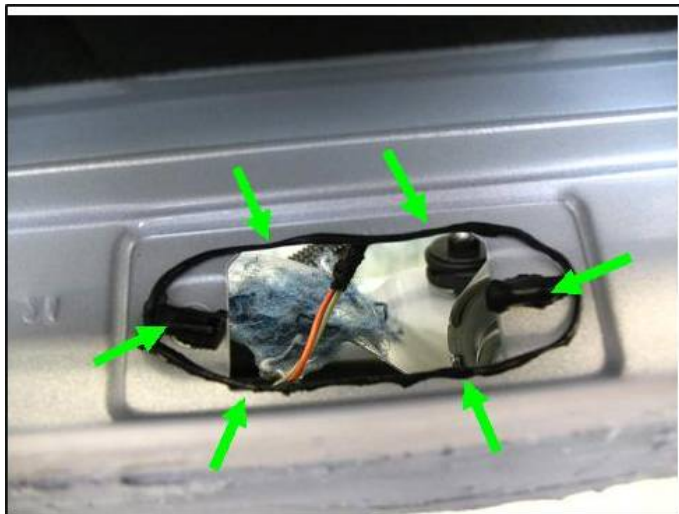
Figure 5) example 1K5 –License plate light, contact surface and hole sealed with butyl sealing cord
