Technical Bulletin

Model(s)	Year	Eng. Code	Trans. Code	VIN Range From	VIN Range To
Passat Wagon	2006 – 2010	All	All	All	All

55 14 11 December 16, 2014 2039197

Corrosion On Rear Lid Around Rear Lights

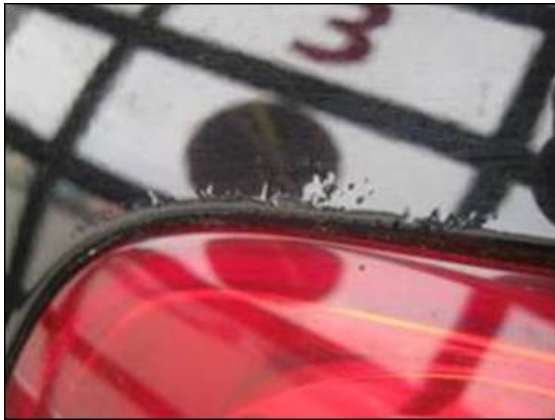
Figure 1: Example: rear lid when rear light is installed

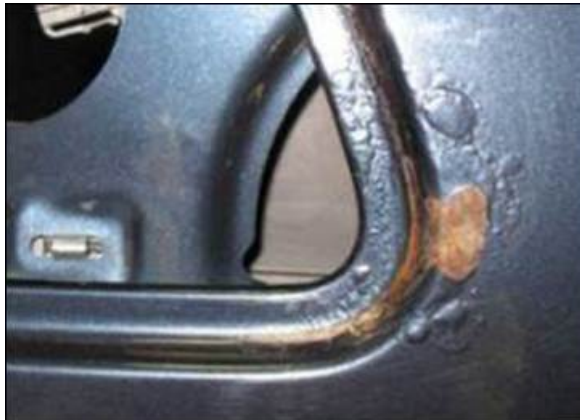
Figure 2: Example: rear lid when rear light is removed

The surface area of the rear lid becomes chafed from movements between the components.

Repair the rear lid (remove corrosion/restore paint structure).

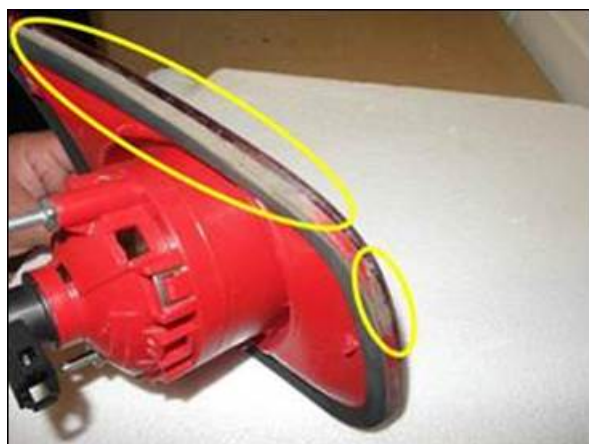
Dirt between the rear lid surface and rear lights can cause paint damage (Figure 3).

Figure 3 Dirt on rear lights

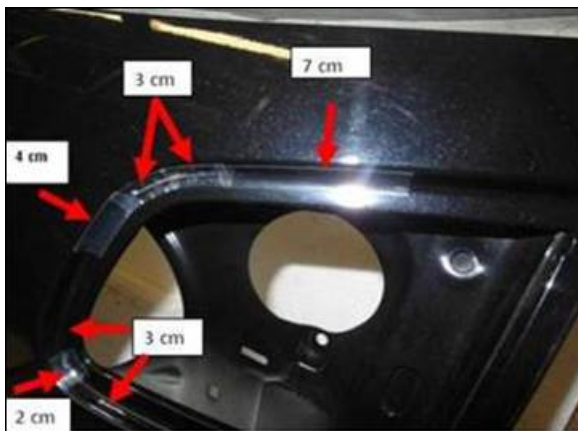
Figure 5 Foil installation on right lift gate tail light surface.

Cut out the anti-chafing foils per side from the part number: AKL 448 030 05 (Figure 5, red arrows)

- For top area: 1 x 7 cm long, 2 x 3 cm long, 1 x 4 cm long.
- For bottom area: 1 x 2 cm long, 2 x 3 cm long.
- Thoroughly clean the contact surface of the rear lights in the rear lid with silicon remover
- Stick on the cut-out foils (illustration 5, red arrows).

When applying the anti-chafing foil make sure that the edge to the outside is equal and is covered by the rear lights.
