Technical Bulletin

97 14 02 May 1, 2014 2037108

MIL ON, DTC P0236 Turbocharger Boost Sensor (A) Circ. Range Performance Stored in ECM Fault Memory

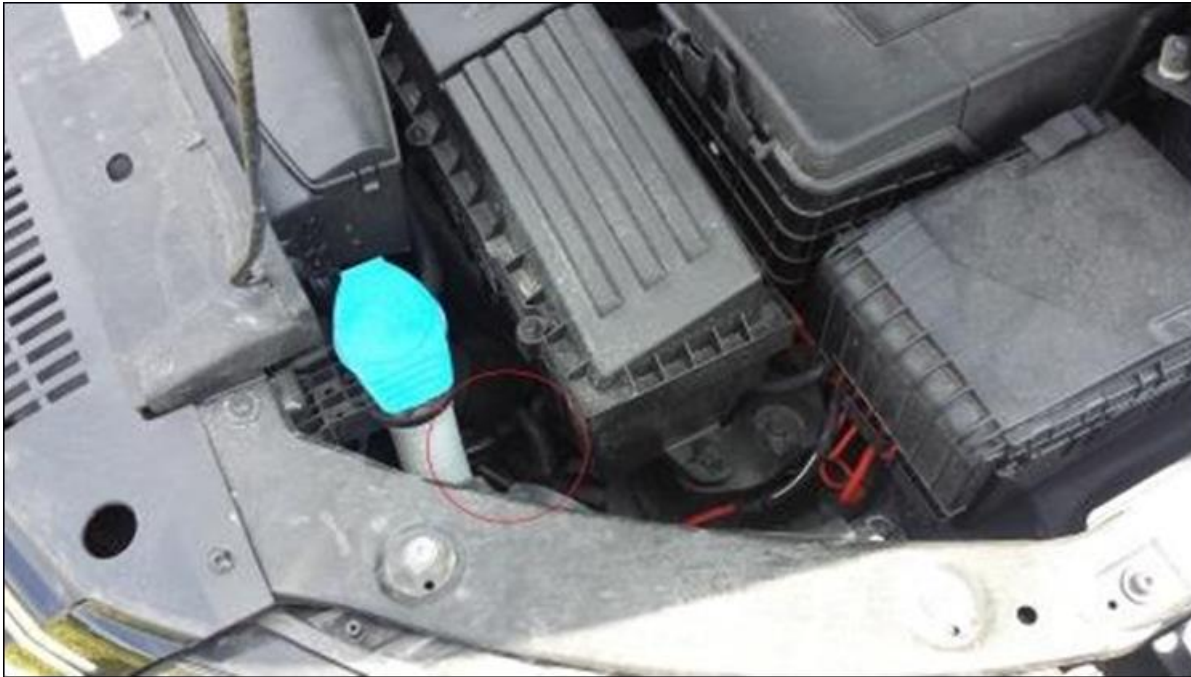
Figure 1

- Locate the T14 connector in front of the air box, behind the left front headlight. Wiring repair to be performed on the engine harness side (male pin side) (figure 1).
