# Technical Bulletin

Model(s)	Year	Eng. Code	Trans. Code	VIN Range From	VIN Range To
Tiguan	2013-2014	2.0L (CCTA)	All	All	All

97 14 03 June 12, 2014 2037108 Supersedes TB V971402 dated May 1, 2014 to avoid confusion and remove pre road test labor operation from warranty table.

MIL ON, DTC P0236 Turbocharger Boost Sensor (A) Circ. Range Performance Stored in ECM Fault Memory

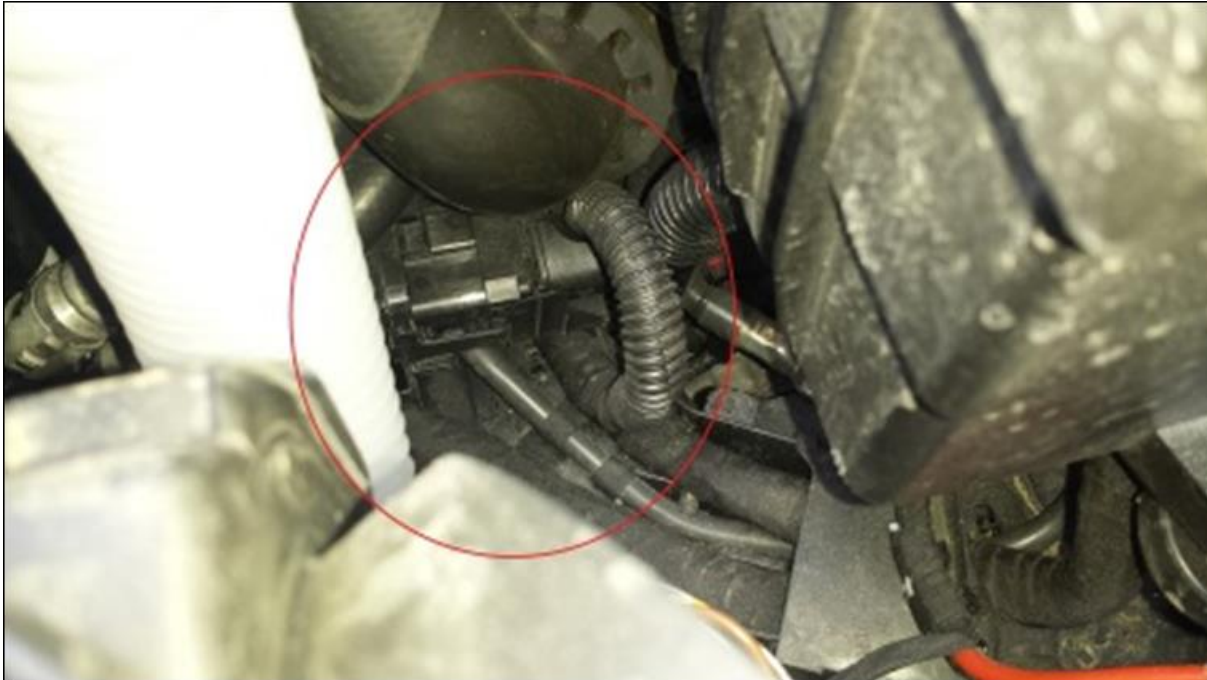
Figure 2

- Remove the air box to gain access to make the wiring repair (figure 2).

- Locate pins 12, 13 and 14 within the T14 connector.
- Using the VAS 1978 Wiring Harness Repair Kit, remove and replace pins 12, 13 and 14, 23cm (9 in.) behind the wiring harness end connector.
