Technical Bulletin

58 14 01 July 25, 2014 2037792

Rattle Noise from the Right Rear Sliding Door While Driving Over Bumps

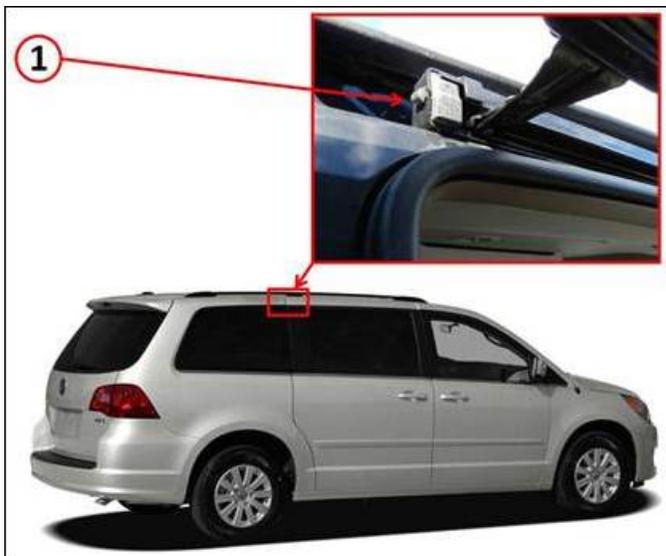
Fig. 1 Remove Bumper

Rattle noise that sounds like metal against metal coming from the right rear sliding door area while driving over bumps.

3. Open the right rear sliding door, remove the rubber bumper (Fig. 1) from the rear end of the upper door track and close the door.

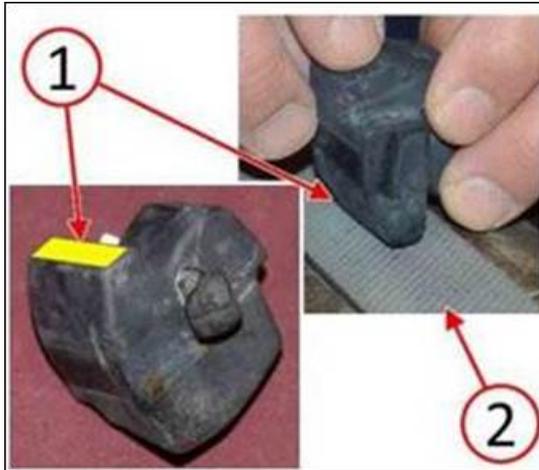
Fig. 2 Modify Bumper

This bulletin involves modifying the rubber bumper located at the rear end of the right rear sliding door upper track.

5. Using a coarse file (2), remove 1 mm of material from the rubber bumper surface (1) indicated in (Fig. 2).

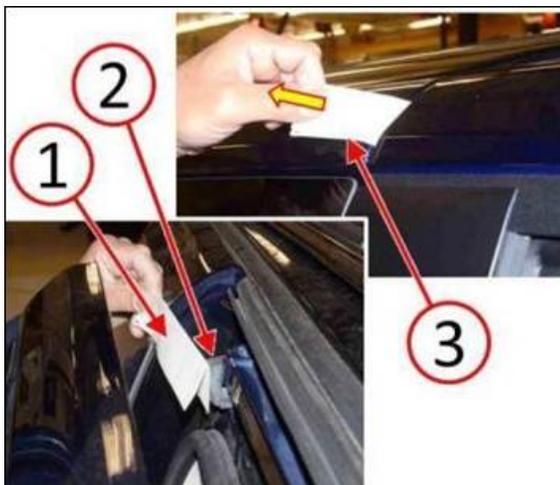
Fig. 3 Check Bumper Clearance

There is an intended design clearance of approximately 1.8 mm between the rubber bumper and the sliding door inner panel.

If tension or resistance was felt while removing the slip of paper, that would indicate a contact interference condition between the rubber bumper and the door inner panel.

7. Hold a piece of paper (1) in front of the rubber bumper (2). Make sure fingers and hands are clear of the door opening then shut the door while holding the paper in position (Fig. 3).

8. Slowly pull the paper (3) while feeling for any tension or resistance on the paper during paper removal (Fig. 3).

A: YES, tension or resistance was felt. >>> Repeat the rubber bumper material removal Step #5 and retest B: Clearance with the slip of paper until no tension or resistance is felt.
