Technical Bulletin

Model(s)	Year	Eng. Code	Trans. Code	VIN Range From	VIN Range To
Touareg	2004 – 2010	All	All	7L_4D000001	7L_AD005286

58 14 02 December 16, 2014 2039001

Corrosion, Rear Inner Doors in Door Fold Area

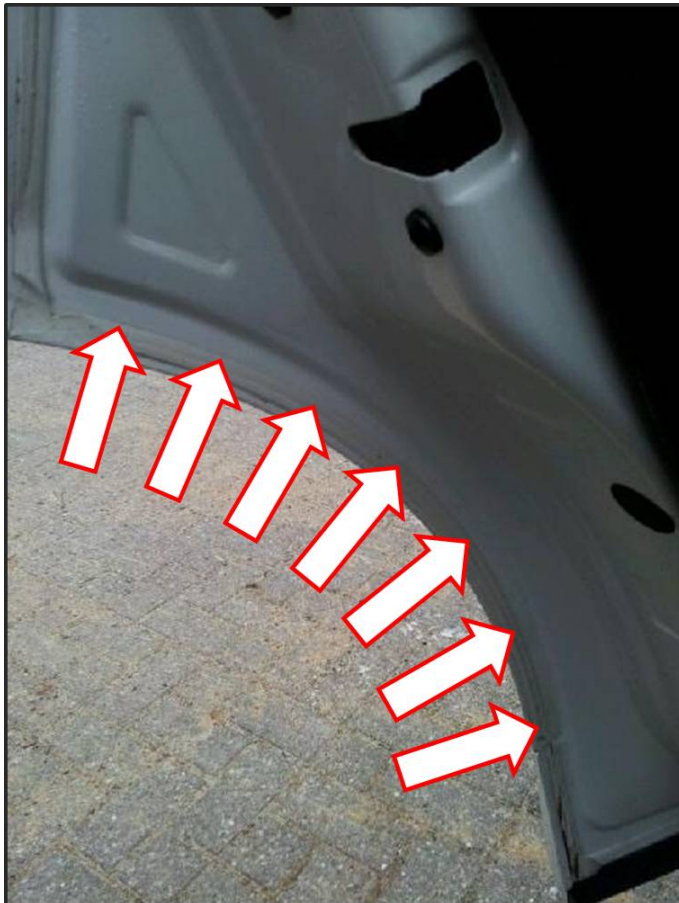
Corrosion in the fold of the rear door.

Figure 1) Arrows show the area affected by corrosion

1. Fine seam sealing in the area of the rear door fold not optimal.
2. Bonding of the rear door in the metal fold not optimal.
3. Incorrect or no cavity coating.

1. Repair the rear door fold **Only perform this operation if the total repair cost is 80% or less of the total replacement cost.**

2. Replace the rear door

If the door fold is only lightly corroded (no through-corrosion), proceed as follows:

- Protect the outer door area against damage by covering the door fold area with masking tape.
- Remove corrosion and fine seam sealing in the damaged area using a pneumatic brush grinder.

- Apply a VOC compliant epoxy primer as an anti-corrosion treatment and primer (locally sourced).
- Restore the fine seam sealing according to the repair manual.
- Restore the paint structure according to Volkswagen guidelines.

- Replace the door according to the repair manual. See Repair Manual Group 58 in Elsa.
