Technical Bulletin

Model(s)	Year	Eng. Code	Trans. Code	VIN Range From	VIN Range To
Phaeton	2004 –2006	All	All	All	All

58 14 04 December 18, 2014 2039211

Corrosion on Rear Doors (Multiple Locations)

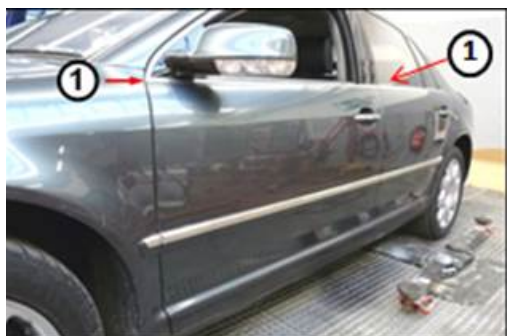
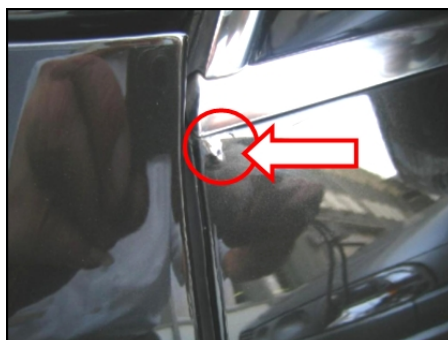
Figure 1 – Upper window channel strip

Figure 1.1

Alignments in production can lead to hairline cracks in the top coat and paint damage (edges on holes) on the already painted door. Humidity then penetrates paint and causes blistering and/or white corrosion.

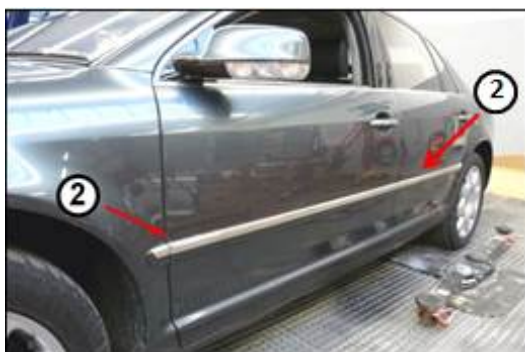
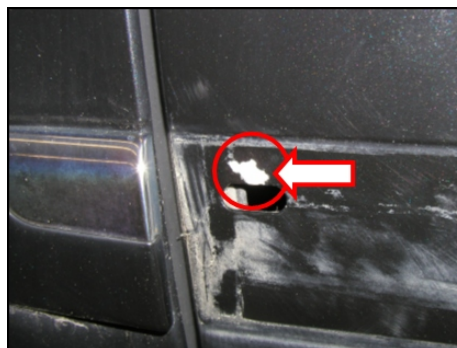
Figure 2 – Central protective strip

Figure 2.1

1. Central protective strip

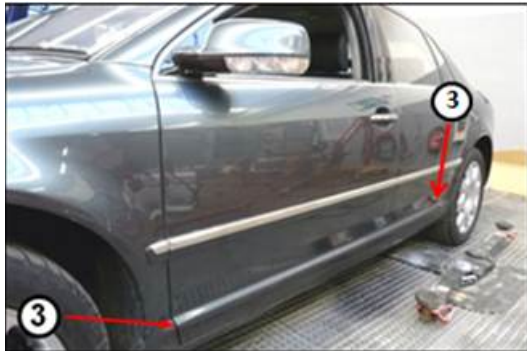
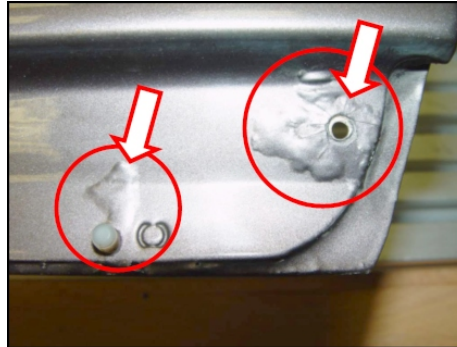
Figure 3 – Lower protective strip

Figure 3.1

2. Lower protective strip

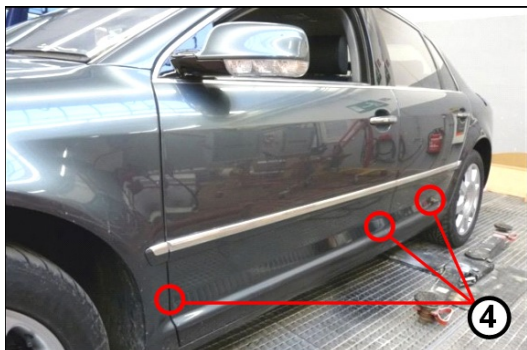
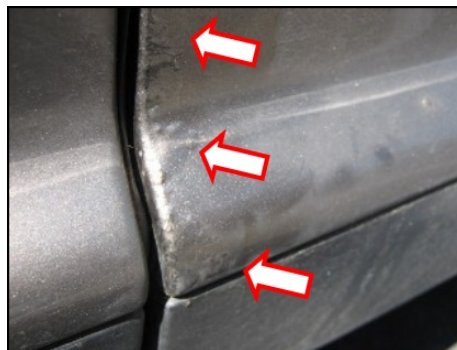
Figure 4 – Surface/edge corrosion

Figure 4.1

- Inspect the inner edge area of the doors for cracks, particularly the fine seam sealing.
- Completely remove the corrosion in the damaged area.
- Apply a VOC compliant epoxy primer as an anti-corrosion treatment and primer to both sides of the door (locally sourced).
- Seal the edges/metal sheathings with adhesive (part number: AKD 476 KD505) before painting.
- Repaint door according to Volkswagen guidelines

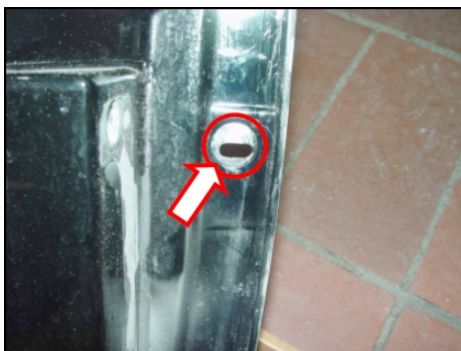
Figure 5

Holes and edges in the flange area
