# Technical Bulletin

**87 14 04** June 19, 2014 **2037095** Supersedes Technical Bulletin V871403 dated June 18, 2014 to update procedure due to double retainer coming with new coolant hose and not as an additional part.

**Air Conditioning Blows Warm, Compressor-Condenser Refrigerant Line**

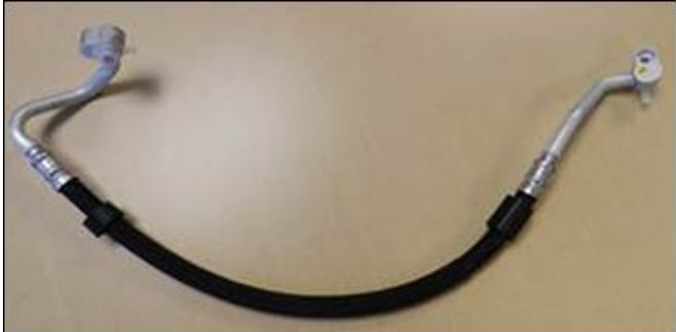
New refrigerant compressor/condenser hose 5N0 820 721H.

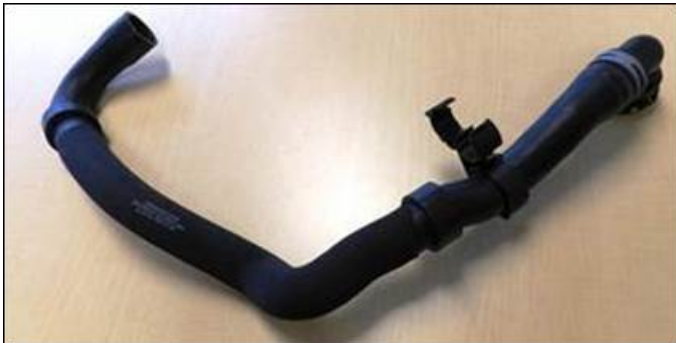
New coolant hose with double retainer refrigerant line holder 5N0 121 093L.

New coolant hose comes with new retainer 5N0 121 093L.

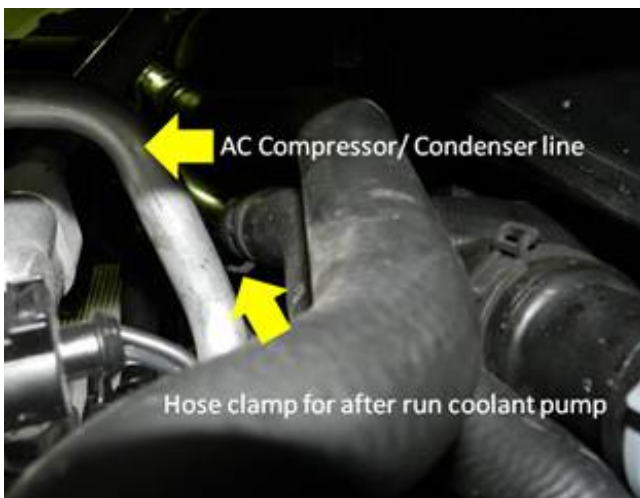
**The picture shown in Figure 2 shows the AC line installed to capture the potential contact area.**

- Locate the after run coolant pump and turn the clamp  $\frac{1}{2}$  a turn from its original location away from the compressor/condenser line.
