Technical Bulletin

21 13 01 September 4, 2013 2025464 Supersedes T. B. V211201 dated March 12, 2012 to include additional model year and Beetle, Beetle Convertible applicability.

Frozen Charge Air Cooler – Engine Will Not Start

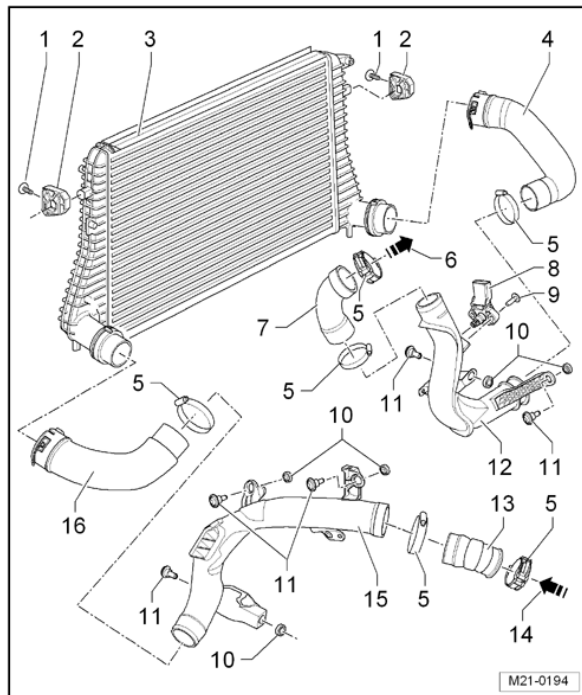
Figure 1

Moisture from the intake air condenses and collects in the charge air cooler. At cold temperatures this moisture can freeze causing blockage of the intake air system.

- Lock carrier in service position. See Repair Manual Group 50 in ElsaWeb.
- Separate A/C condenser from charge air cooler.
- Remove radiator and radiator fan assembly.
- Remove the original charge air cooler (item 3 in figure 1) from the vehicle.

- Remove the lower charge pressure hoses (items 4 and 16 in figure 1) and clean of any moisture or sludge. See Repair Manual Group 21, Turbocharger/G-Charger, Description and Operation, Component Overview, in ElsaWeb.

- Remove cold side charge air pipe (item 12 in figure 1) and pressure hose to throttle valve (item 7 in figure 1).
- Separate the A/C condenser from the charge air cooler.
- Remove the radiator and radiator fan assembly.
- Separate the charge air pressure sensor –G31-- from cold side charge air pipe.
- Install charge air pressure sensor -G31- from kit to cold side charge air pipe.
- Loosely fit the pressure hose with new temperature switch to the cold side charge air pipe.

- Install the cold side charge air pipe (item 12 in figure 1) and connect the charge air pressure sensor -G31- electrical connector.

- Cut vacuum source hose where indicated in figure 7, and install splice.
- Install the revised charge air cooler (item 3 in figure 1) with regulating flap and connect the regulating flap vacuum hose.
- Re-assemble all charge air pipe connections.
- Connect A/C condenser to charge air cooler using fasteners from kit, and install radiator with fan assembly.
- Reassemble front carrier.
- Re-aim headlights.
