21 14 04 May 1, 2014 **2025464** Supersedes T. B. V211301 dated September 4, 2013 to adjust GFF time, include post repair road test and update labor times for Jetta, Beetle, Beetle Convertible per updated repair manual charge air cooler removal and installation procedure.

Frozen Charge Air Cooler - Engine Will Not Start

Technical Bulletin

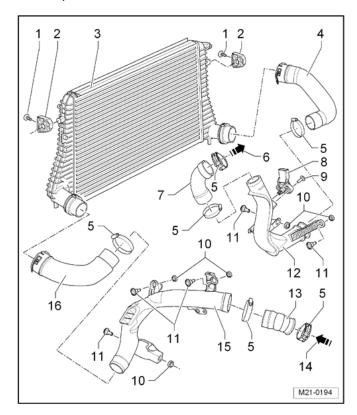
Figure 1

Remove the lower charge pressure hoses (items 4 and 16 in figure 1) and <u>clean of any moisture, ice crystal formation or sludge</u>. See Repair Manual Group 21, Turbocharger/G-Charger, Description and Operation, Component Overview, in Elsa.

- Remove cold side charge air pipe (item 12 in figure 1) and pressure hose to throttle valve (item 7 in figure 1).
- Separate the A/C condenser from the charge air cooler.
- Remove the radiator and radiator fan assembly.
- Separate the charge air pressure sensor –G31-- from cold side charge air pipe.
- Install charge air pressure sensor -G31- from kit to cold side charge air pipe.
- Loosely fit the pressure hose with new temperature switch to the cold side charge air pipe.

• Install the cold side charge air pipe (item 12 in figure 1) and connect the charge air pressure sensor -G31-electrical connector.

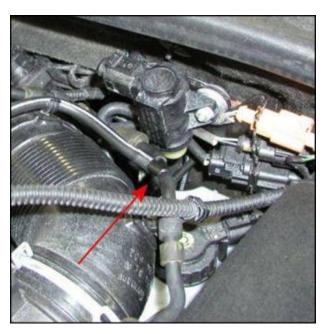
Figure 6

Note the white tracer on the vacuum hose in figure 6.

• Install splice as indicated in figure 6.
