Service Action

Code: 93A7

Subject: 2015 MY eGolf
Cable Tube

December 05, 2014

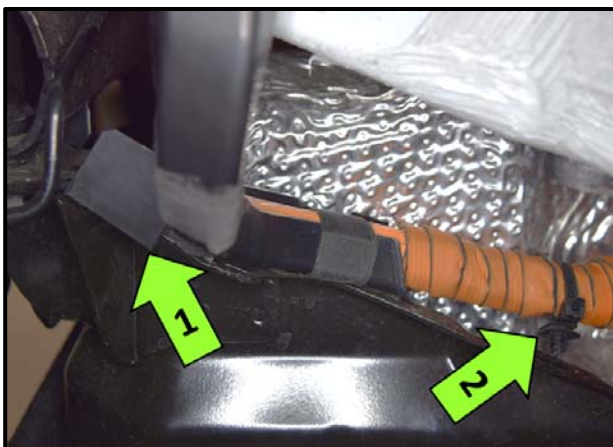
It is possible that a cable tube fastener was not torqued correctly during vehicle production. This can lead to a rattling noise near the charge port, and can also impact the vehicle's ability to fully charge.

⇐ Release the cable tube fastener <arrow 1>.

⇐ Remove the cable fastener <arrow 2>.

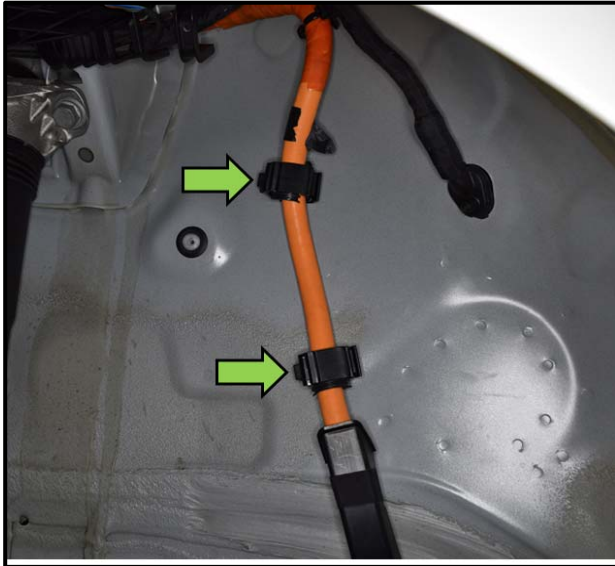
Be aware of the protective mounting sleeves located under the mounting clips as they must be reinstalled in their original position. An improperly positioned mounting sleeve could result in chafing damage to the charging cable.

⇐ Refasten the two upper mounting clips making sure that the two protective mounting sleeves are in their correct position <arrows>.
