Technical Bulletin

Model(s)	Year(s)	Eng. Code(s)	Trans. Code(s)	VIN Range From	VIN Range To
Touareg, Touareg 2	2007-2009	3.6L (BHK)	All	7L_7D000001	7L_9D017949

01 14 05 February 21, 2014 2019434 Supersedes T.B. V011206 dated March 14, 2012 to correct Technical Diagnosis labor operation coding in the warranty table.

MIL ON, DTCs P0325 or P0327 Stored in ECM Fault Memory

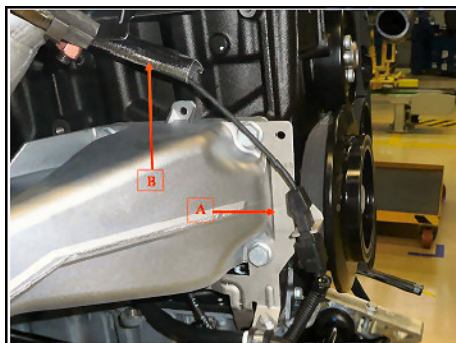
Figure 2

- Inspect whether or not knock sensor bracket Part No. 03H 971 501 D (the new knock sensor bracket that is twisted 15°) is installed.

If the old knock sensor bracket 03H 971 501 A is installed:

- Replace with the new bracket Part No. 03H 971 501 D (Figure 2, inset A).
