Technical Bulletin

01 14 11 April 21, 2014 2034898 Supersedes T.B. V011333 dated October 23, 2013 to include labor operation for component exchanging between original and replacement part.

MIL ON, DTC P0401 Exhaust Gas Recirculation Flow Insufficient Stored in ECM Fault Memory, Could be accompanied with Fault P2463 DPF Soot Accumulation

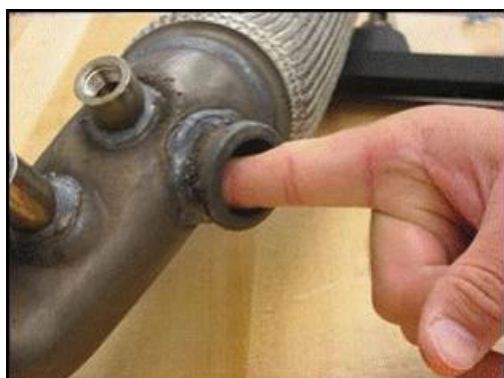
Figure 1

- Remove the EGR filter from the DPF and swipe the inside of the exhaust pipe at the EGR filter connection point using a clean cloth or your finger. See figures 1 and 2 below.

If your finger or the cloth comes out with black soot, replace the DPF & EGR filter together.

When replacing the DPF for the fault P0401 it is important to replace both the DPF and the EGR filter together, as soot accumulation in the EGR filter is undesired. It is NOT necessary to replace any other components for this fault (i.e. NOx Storage Catalyst, Sulfur Catalyst, Exhaust Flap, EGR Cooler), these components should be reinstalled in the vehicle with the new DPF and EGR filter.
