Technical Bulletin

Model(s)	Year	Eng. Code	Trans. Code	VIN Range From	VIN Range To
All	2009-2014	2.0L TDI (CBEA, CJAA)	All	All	All

15 14 02 March 21, 2014 2032150 Supersedes TB V151203 dated December 20, 2012 to include 2014 model year applicability.

Proper Removal of Engine Cover to Avoid Breakage

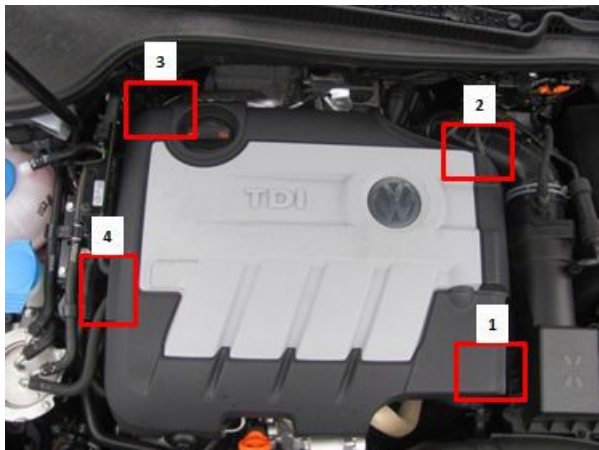
Figure 1

Pulling on the engine cover in some areas can cause damage

Engine cover damage can occur during removal.

Care should be taken when removing the engine cover for service. During periods of cold weather, if possible, allow the material to warm indoors prior to removal.

When removing the cover, lift from the corners in sequence as illustrated (figure 1), placing your fingers underneath the cover, around the mount, to support the cover as you lift upwards.
