# UPDATE Technical Bulletin

February 19, 2014

## UPDATE – 55H9 Fuel Door (NVLW)

Model(s)	Year	Engine Code	Trans. Code
Jetta, Jetta Hybrid	2014	All	All

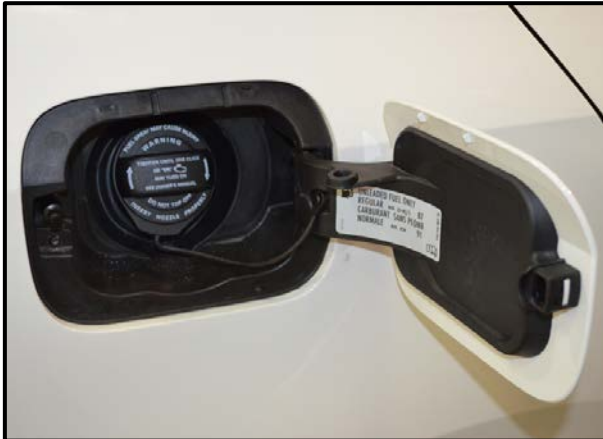
⇐ Open the fuel door.

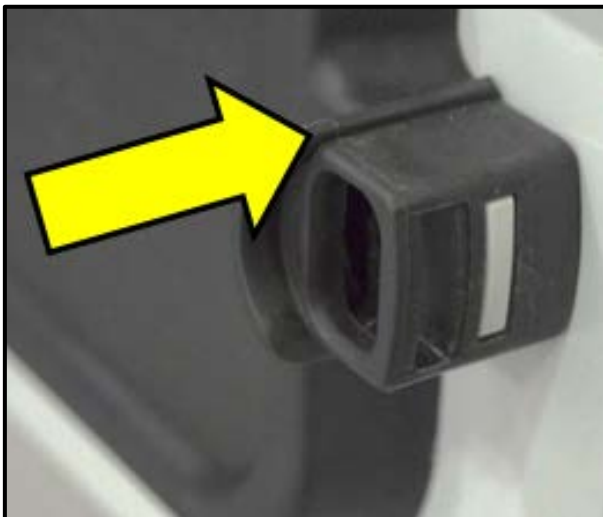
Fuel door binding or sticking due to excess material inside of the fuel door housing.

⇐ Identify the area of the fuel door latch as shown <arrow> containing excess material.

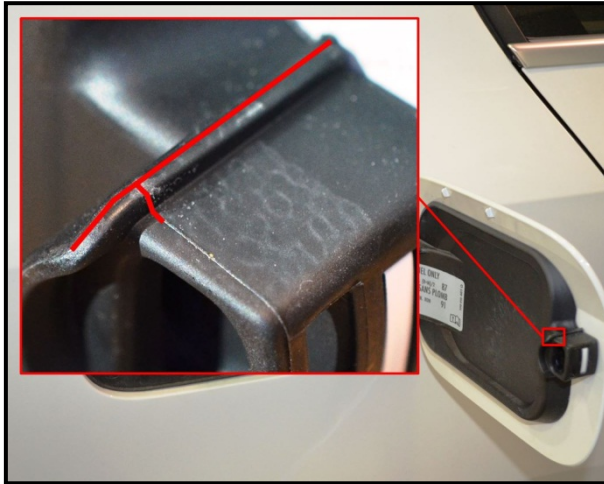
Tip: Excess material and burrs may be present along the ridge of the housing where the plastic seams join together as shown <red lines>.
