VW Elsa Newsletter

Edition 82: April 21, 2014

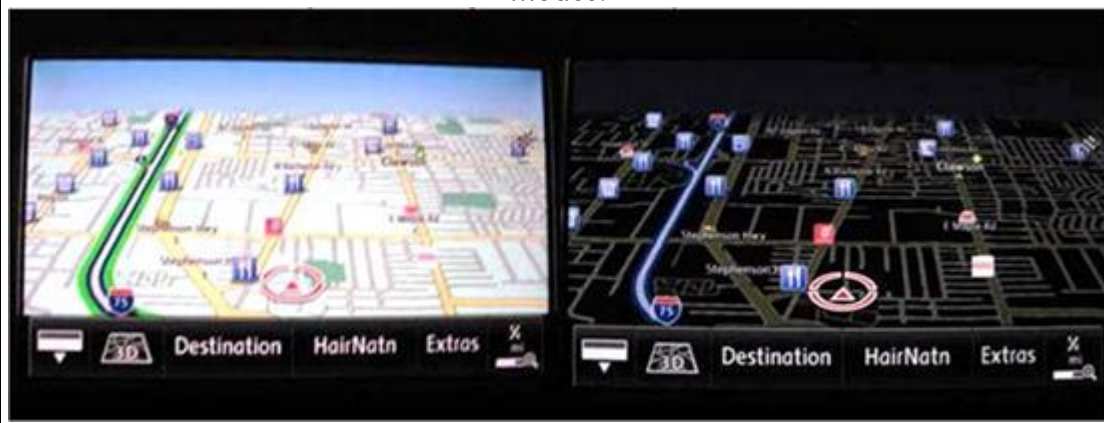
91-11-09 All Navigation Radios - All Models April 18, 2014: Update to information.

When the Navigation RNS 850/510/315 is in 3D mode, the top portion of the screen may not display streets. This line represents the horizon and is a normal operation of system. No repairs should be made. Examples below of day and night modes:
