VW Elsa Newsletter

Edition 117: December 22, 2014

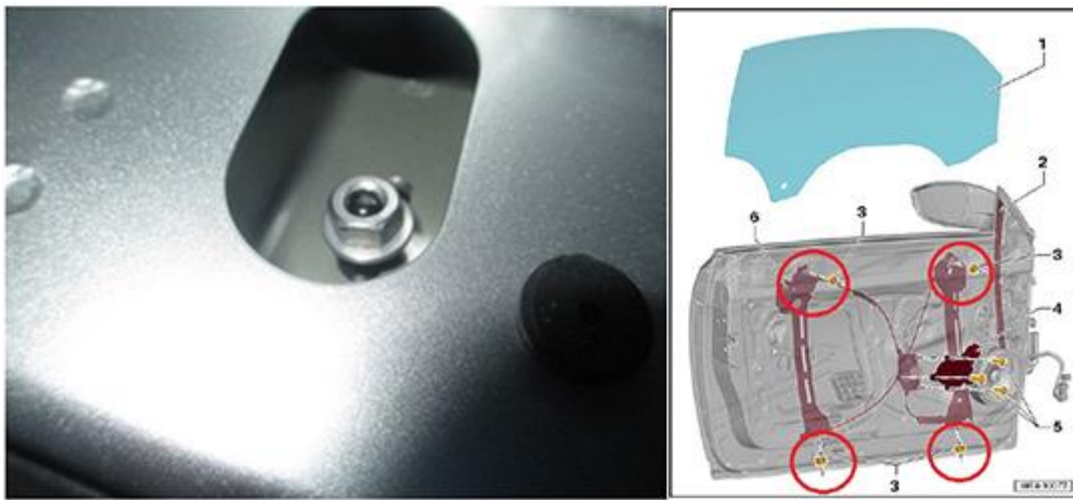
Fig. 1

Complaints of a rattle noise when closing the front door, or rattle from door when driving on bump roads may be caused when the front window regulator mounting nuts have become loose in the door. This concern may be more noticeable with the window closed. (See Fig. 1)

This occurs due to insufficient torque on the fixation nuts for the window regulator. The regulator rails can then move in the door creating the noise concern.

- Remove the front door trim panel to gain access to all four window regulator mounting nuts; see Repair Manual Group 70, Interior Trim in Elsa.
- Remove the caps for the front window regulator nut on the underside of the door.
 - Remove the caps for the upper window regulator nuts on the door.
- Remove and replace the 4 regulator mounting nuts with part number N 908 877 03.
- Adjust the front door window accordingly; see Repair Manual Group 64 Glass, Window Regulators in Elsa.
- Once the front door window is properly adjusted, torque the regulator fixation nuts to 8 Nm using torque wrench 1783 (VAG1783).
