VW Elsa Newsletter

Edition 86: May 19, 2014

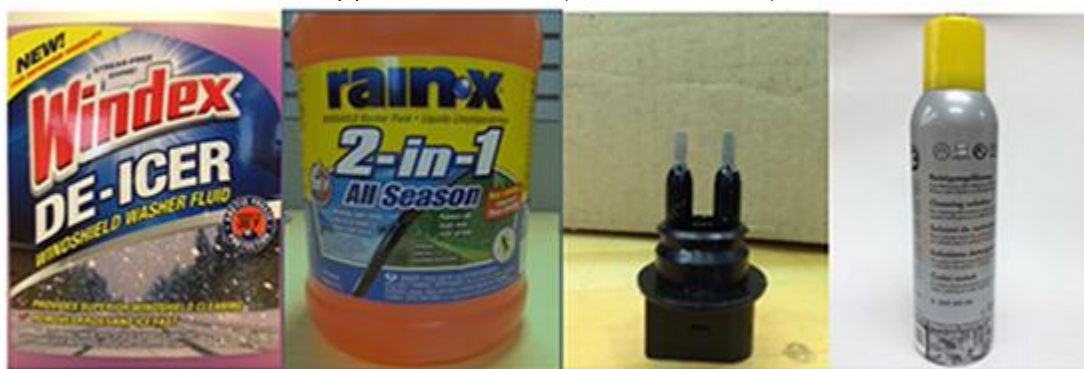
92-14-02 Washer Level Sensor

The indicator lamp in the I.P. for washer fluid remains illuminated and the washer reservoir is full. Validate the washer reservoir is full with the proper washer solvent (G-052-164). Refer to Elsa for proper fluid type and fluid quantities under repair manual, maintenance, fluid capacity table. If the fluid is not blue in color, drain the fluid, remove the sensor and clean with cleaner (D-009-401-04) or equivalent. Reinstall the sensor, top off washer reservoir with proper fluid and validate that the indicator lamp in the I.P. is no longer illuminated.

Non-approved fluids can cause residues to form on the sensor which causes the washer fluid lamp to remain on when reservoir is full. Below are examples of non-approved fluids, a picture of the sensor in question (G33) and a picture of the approved cleaner (D-009-401-04).
