VW Elsa Newsletter

Edition 112: November 17, 2014

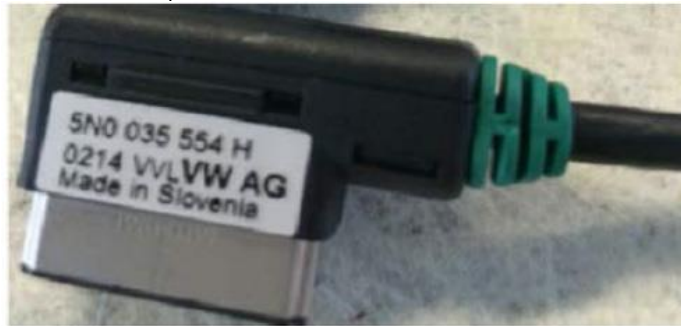
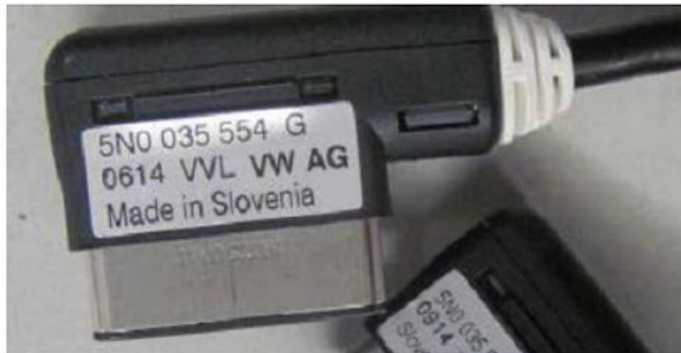
**91-14-04 Entertainment Center MDI Cables
November 14, 2014: Update to Information.**

For the A7 Golf/GTI the MDI cables are not the same as the ones used in the A6 Platform. Below you can see it is easy to tell the difference. If the vehicle is found to have a white collar cable, the correct cable will need to be used. Refer to ETKA for the correct cable needed depending on the device being used.

Note: These cables are no longer provided from the factory with MY15 vehicles produced after 6/31/2014.
