VW Elsa Newsletter

Edition 102: September 8, 2014

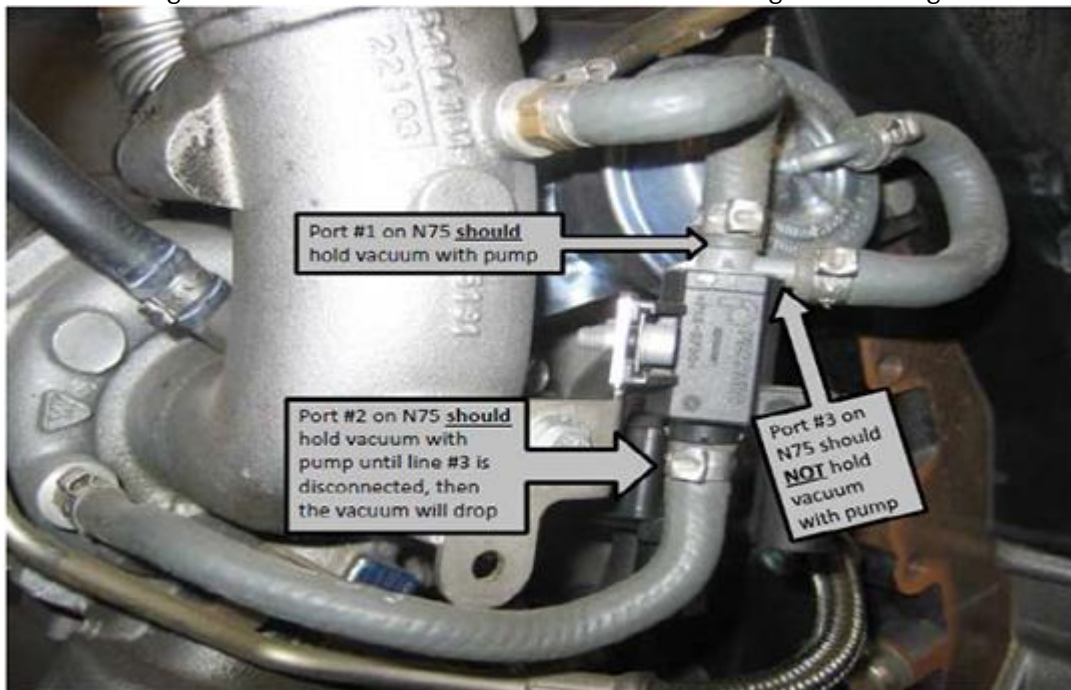
21-10-01 N75 Solenoid Valve Diagnosis

When diagnosis on the above engine leads to the testing of the N75, please refer to the picture below. The diagram shows which vacuum ports on the N75 valve should hold vacuum and which ones should not.

Turbocharger fault codes P0299 and P0234 can be diagnosed using this test.

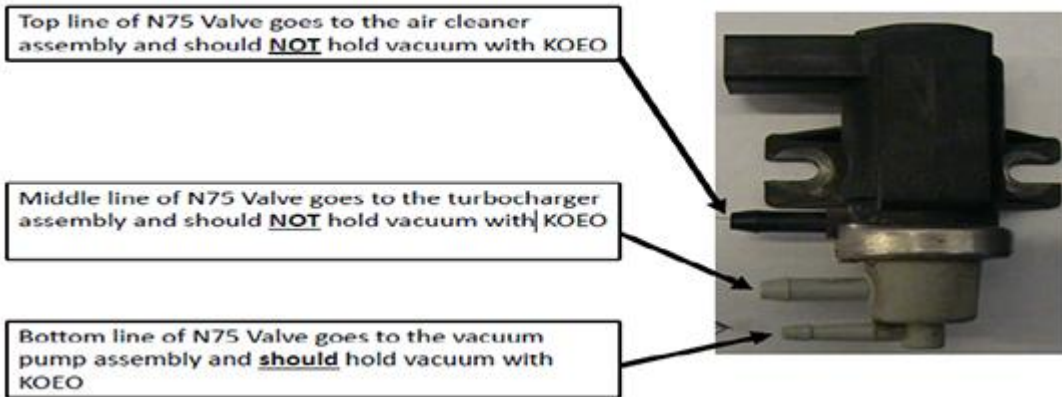
TDI N75 Testing

Use the diagram below to test the N75 Solenoid Valve in the event of a turbocharger fault code such as P0299 or P0234. This applies to Mechanical Injection Style Diesel Engines, Pumpe Duse Style Diesel Engines and the new Common Rail Style Diesel Engines.
