VW Elsa Newsletter

Edition 94: July 14, 2014

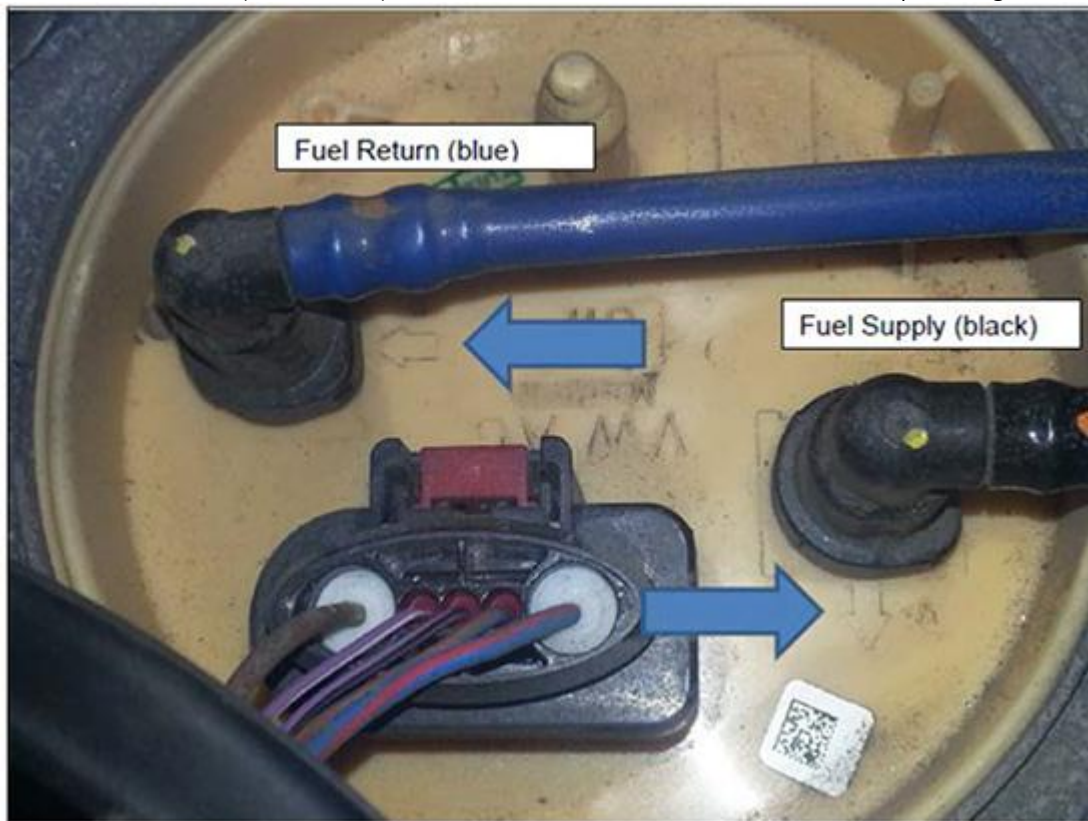
20-13-02 Fuel line connections

Be aware that fuel lines are color coded on vehicles with return fuel pressure lines. The black line is for fuel pressure supply and the blue line is for fuel pressure return.

To verify correct line installation, remove the metal cover exposing the fuel pump flange assembly (generally under the rear seat). Refer to the ELSA Repair Manual for specific location. Check for raised arrows on the flange housing. The black line (Fuel Pressure Supply) attaches to the connection with the arrow pointing away from it. The blue line (fuel return) attaches to the connection with arrow pointing to it.

On 2009-2013 Common Rail Diesel Engines with a whining noise from the auxiliary fuel pump, verify correct fuel line installation at the in tank fuel pump. Additionally, verify correct line installation at the fuel filter (compare to a like unit or Elsa Repair Manual).
