VW Elsa Newsletter

Edition 89: June 9, 2014

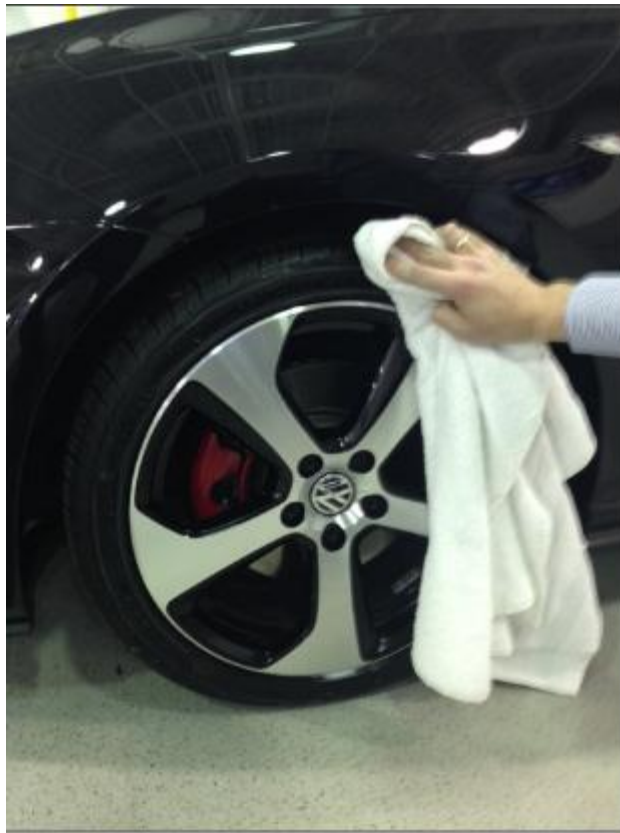
Figure 1: Remove excessive residue

1. Spray a thin, uniform coating of dressing concentrate directly onto the tires and allow to dry.
2. Remove overspray from the wheels, hubcaps or painted surfaces using a clean, soft, dry terry cloth towel (figure 1).

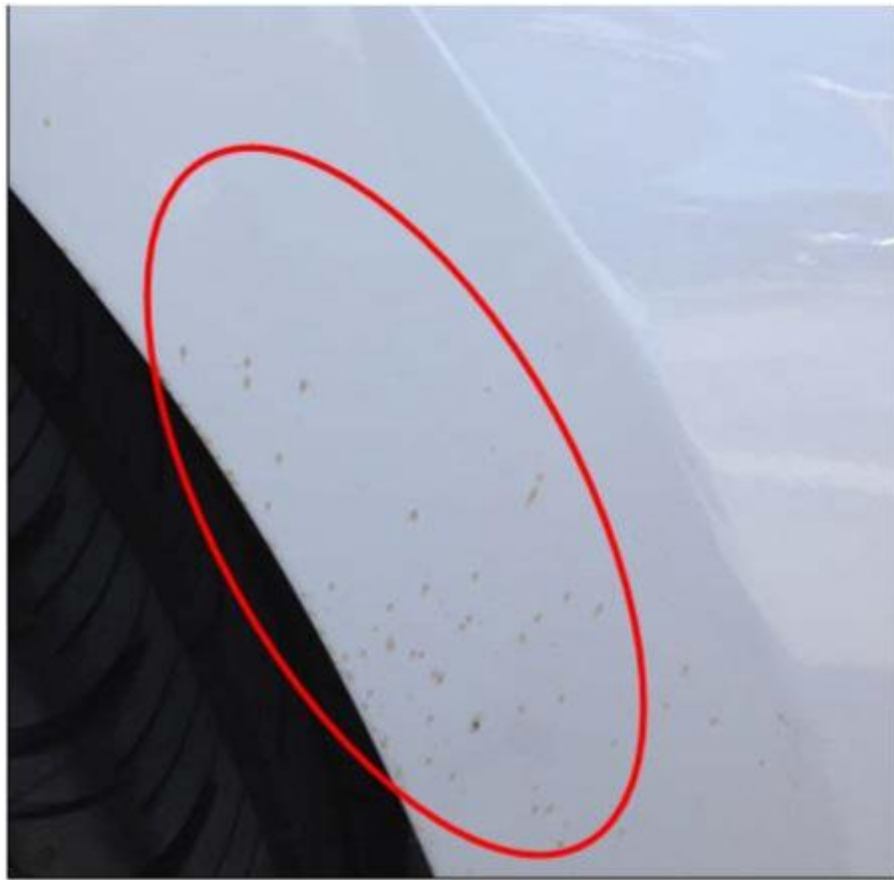
Note: The use of non-water based products will increase the risk of causing damage to painted surfaces.

Figure 2. Paint damage due to slinging tire dressing residue.

Note: Remove excessive residue from painted surfaces directly after applying it on to the tires. Doing so will prevent for possible damage to painted surfaces (see Figure 2).

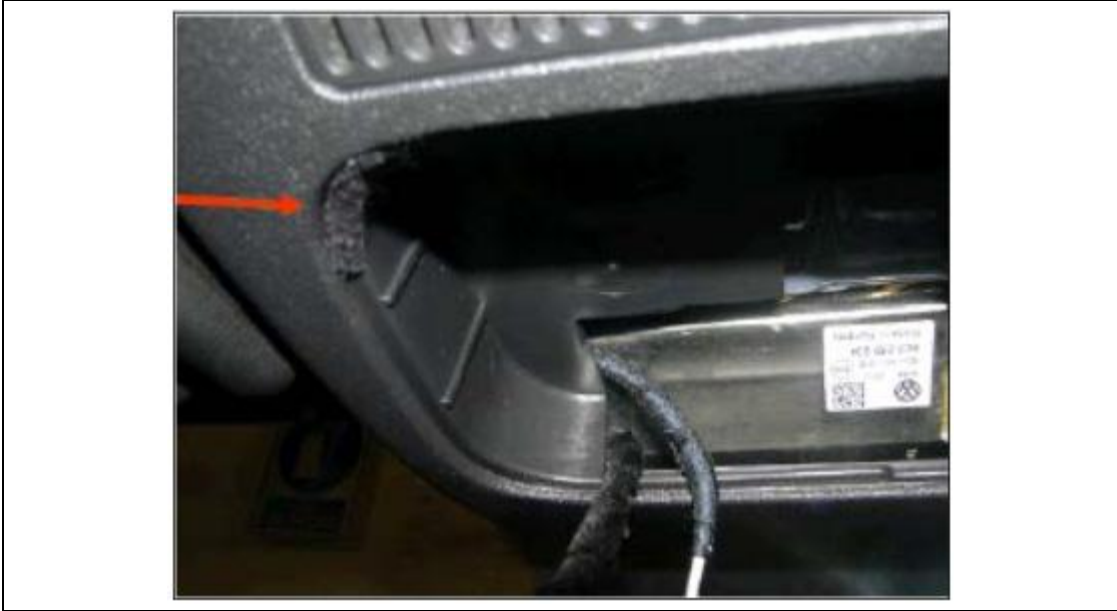
96-14-04 Interior Light Assembly Rattle Noise

For concerns of rattle noise from the interior light assembly, the issue can be corrected with self - adhesive felt from the squeak and rattle kit or by using part number 533 - 863 - 288 - A (Felt Strip) from ETKA. Cut the felt strip to 5mm x 30mm and place it in the left rear corner of the interior light assembly housing, see figure 1 below. For best results use felt strip that is 1.5mm – 3mm thick.
