# VW Elsa Newsletter

Edition 108: October 20, 2014

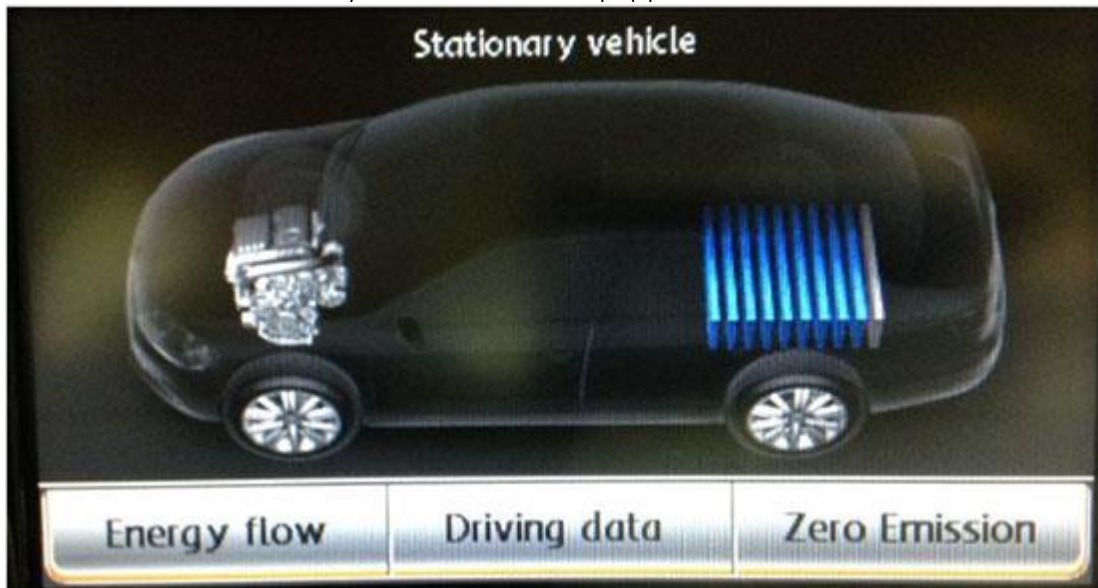
The customer may report that while the vehicle is in motion, the display on the Premium 8 radio displays the “Stationary Vehicle” driving mode. This symptom is often intermittent and can be temporarily resolved by performing a key cycle.

This condition only affects vehicles equipped with Premium 8 radio.

**Note: This technical bulletin must be read in its entirety before attempting the software update.**

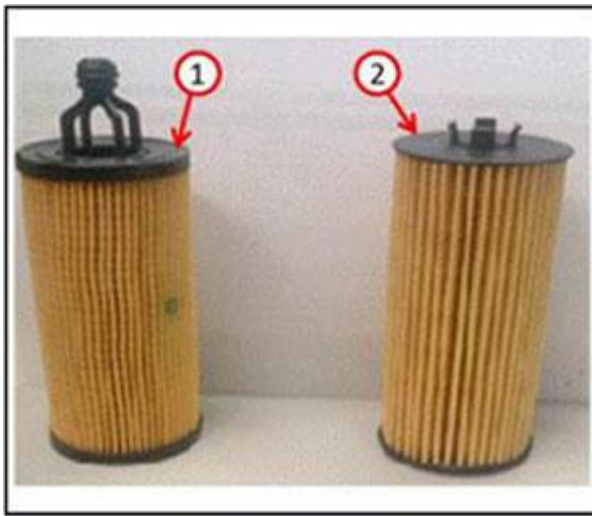
A change was made to the engine Oil Filter Adapter (OFA) for 2014 Model Year vehicles that resulted in a change in the oil filter element. It is important to note that the two different designs are Not interchangeable. Failure to install the correct oil filter **WILL** result in permanent engine damage.

- When replacing the filter, use only the o-ring included in the filter package. Failure to do so **WILL** result in leakage and possible Oil Filter Adapter damage.
  - Also DTC P06DD will result due to incorrect filter application.

1 - 2014 Model Year and Later (P/N 7B0115562A).

2 - 2013 Model Year and Prior (P/N 7B0115562B).

Please remove and inspect the oil filter for correct filter installed.
