Service Bulletin

Bulletin No.: PIT5059B

Subject: Roof Beacon Inoperative (Switch Disconnected)

Models: 2011-2013 Chevrolet Silverado, Tahoe, Suburban
2014 Chevrolet Silverado 2500/3500, Tahoe, Suburban
2011-2013 GMC Sierra, Yukon Models
2014 GMC Sierra 2500/3500, Yukon Models
With Roof Beacon Light (RPO VYU or TRW)

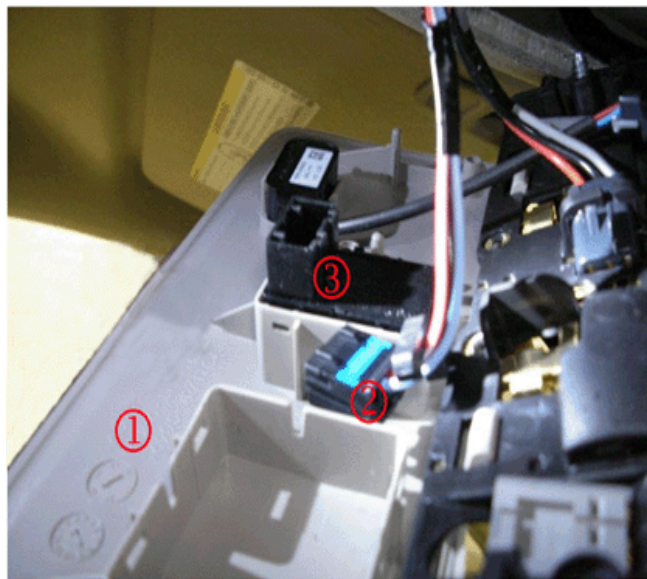
Starting with the 2011 models the roof beacon switch will be left disconnected from the assembly plant. This is to eliminate the risk of a dead battery if the switch is accidentally left on with the ignition key off.

1. Overhead console
2. Beacon Switch Connector
3. Beacon Switch

When a roof beacon light is added, the switch will need to be connected, see picture below.
