Service Bulletin

Bulletin No.: 13-06-01-003F

Subject: Excessive Oil Consumption – Perform Oil Consumption Test and/or Install Piston and Piston Ring Kit

Models: 2010-2013 Buick LaCrosse
2011-2013 Buick Regal
2012-2013 Buick Verano
2010-2013 Chevrolet Equinox
2012-2013 Chevrolet Captiva, Orlando (Canada Only)
2010-2013 GMC Terrain
Equipped with 2.4L Engine (RPOs LAF, LEA)

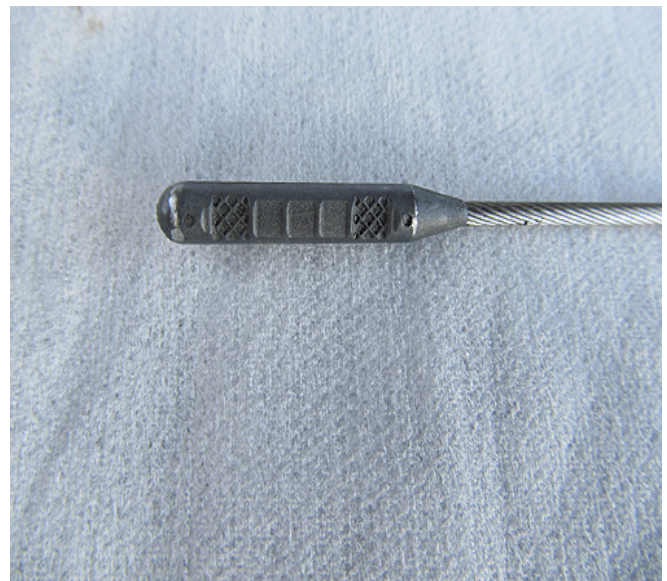
3339530

Important: When checking the oil level with the oil dipstick design shown below, please note that the oil volume per notch is not linear due to the shape of the block. The upper notches (relative to the top of the handle) equal 0.24 quart (0.227 L) between each notch while the lower notches only equal 0.14 quart (0.132 L) between each notch. As a result, no oil will appear on the dipstick if it is low on oil by approximately 1.25 quarts (1.18 L) or more. When determining the oil consumption rate, the oil volume added to return it to the starting location is the total amount of oil consumed. The consumption rate must be documented on a repair order.

Notice: Do not add too much oil. An overfill can lead to burn off of the excess oil. Advise the customer to wait until the oil is below the cross-hatched area at the tip of the dipstick before adding oil.

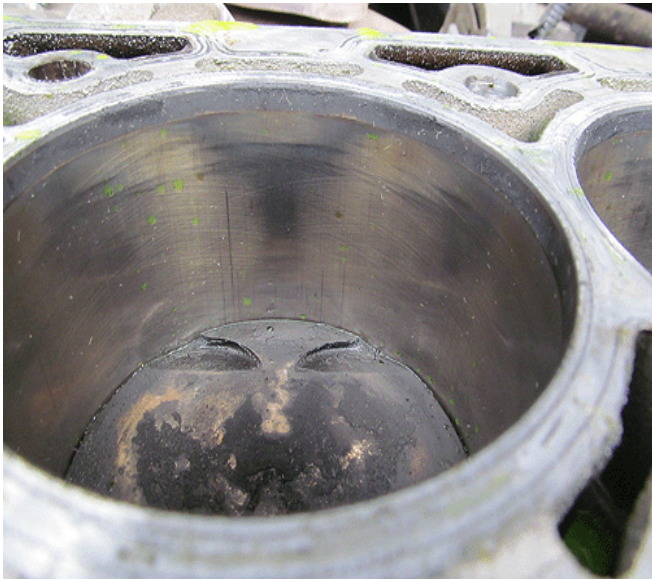
3339531

The repair is to replace the pistons and rings. In some cases the bore surface may not have a uniform look to the finish (zebra stripes) as shown below. As a result, some technicians may question whether the engine should be repaired or replaced. After careful evaluation, GM Powertrain has determined that the new pistons and rings will perform correctly in bores that have this appearance so engine replacement should not be necessary. The cylinder bores do not need any machine or honing work performed on them. Refer to the picture below for acceptable surface finishes.

Acceptable Cylinder that Does Not Appear Uniform (Zebra Stripes)

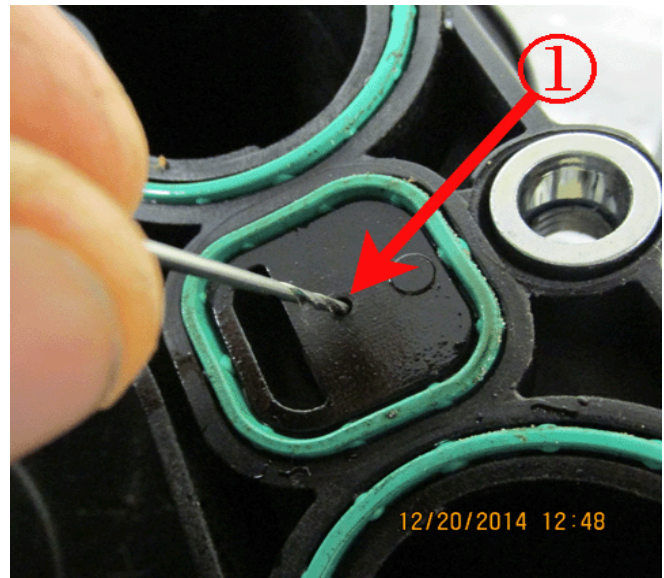
The oil consumption may have clogged/ reduced PCV flow. The PCV system should be serviced.

- (1) PCV orifice in the intake manifold

Clean any ice/sludge/water/carbon out of the PCV pipes/hoses, the PCV nipple on the cam cover, the PCV orifice between the #2 and #3 intake runners (use a 1/16 inch drill bit as illustrated below).

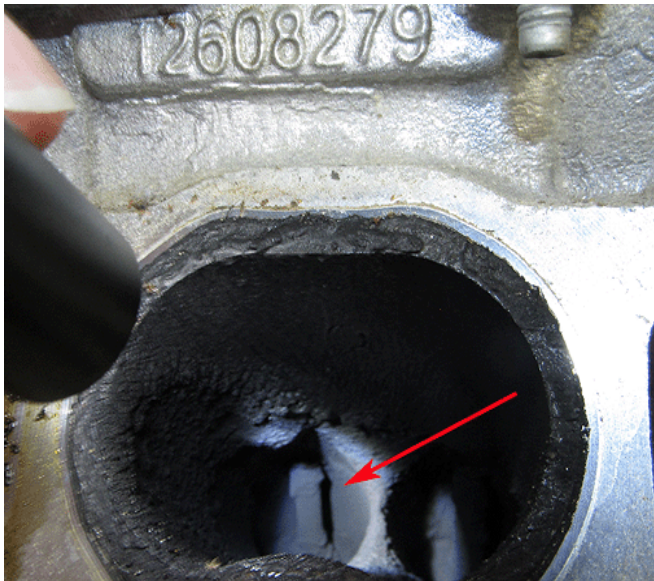
3409680

- Valves stems may have deposits build up on them. These deposits are characteristic of a direct inject engine. The valves stems do not need to be cleaned as they are not affecting engine performance (Refer to picture above).
