PRODUCT SAFETY RECALL

SUBJECT: Electric Power Steering Assist

MODELS: 2004-2006 Chevrolet Malibu, Malibu Maxx
2008-2009 Chevrolet Malibu
2005-2006 Pontiac G6
2008-2009 Pontiac G6
2008-2009 Saturn Aura
Equipped with Electric Power Steering

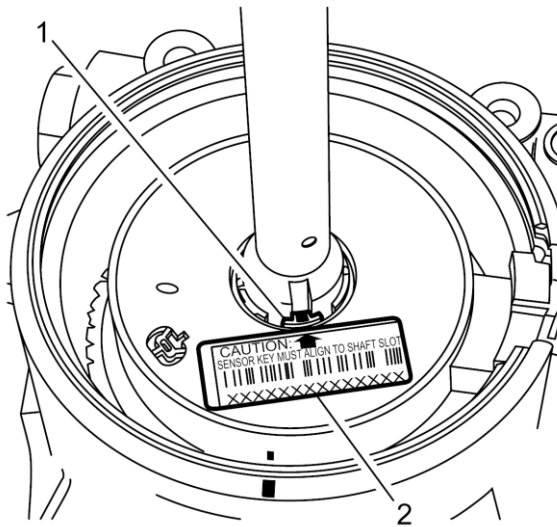
3824308

3. Document the last 9 digits of the NEW steering shaft torque sensor on the vehicle repair order. The serial number is located on the bottom of the caution label (2).

1. Remove the steering shaft torque sensor. Refer to *Steering Shaft Torque Sensor Replacement* in SI.
2. Install a new steering shaft torque sensor. Refer to *Steering Shaft Torque Sensor Replacement* in SI.
