# Service Bulletin

Bulletin No.: PIT5278B

**Subject:** Power Liftgate Erratic Operation Will Not Power Close DTC B153A And/Or Motor Running But Does Not Move

**Models:** 2015 Cadillac Escalade Models  
2015 Chevrolet Tahoe, Suburban  
2015 GMC Yukon Models

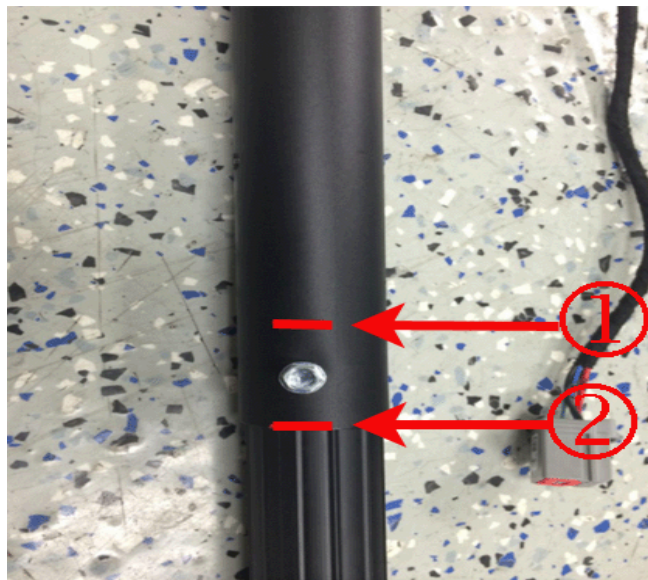
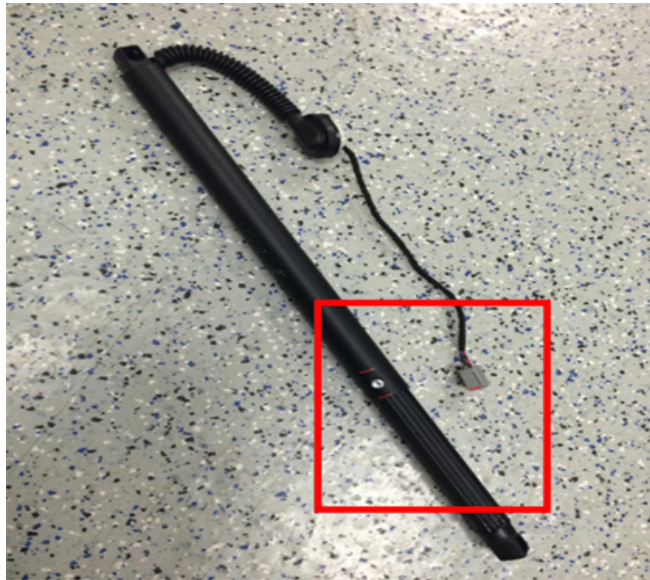
3825800

These concerns may occur if the left liftgate strut/motor actuator is internally coming apart. It will need to be replaced, but care must be taken when removing the left liftgate strut/motor actuator from the vehicle. There is an assist spring inside the strut. If the internal portion of the strut has completely separated, and if it is removed from the vehicle without following the procedure listed below, the end of the strut can become a projectile.

1. Obtain one #8 self-tapping screw 1 1/2 inches long.
2. Fully open the liftgate.
3. Install the self-tapping screw any place in the 30 mm space (from the bottom of the smooth tube) between location 1 and 2. As reflected below, a location of 20 mm (approximately 3/4") is ideal to secure the tubes.

**Note:** The screw will hold the strut together for removal.
