Service Bulletin

Bulletin No.: PIT5281

Subject: Wind Whistle Noise At Highway Speed

Models: 2015 Chevrolet Silverado 2500 / 3500

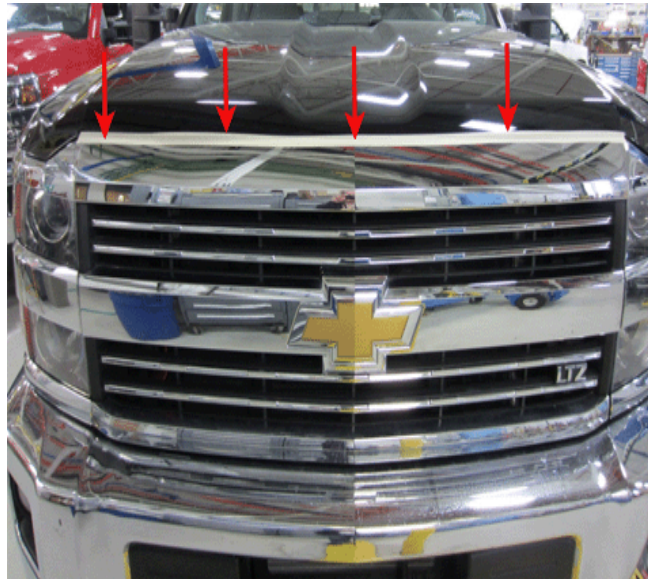
3813273

To root cause this concern, place a piece of tape from the front of the hood to the top of the chrome on the grille. Apply this tape all the way from the left hand side to the right hand side, as shown below.

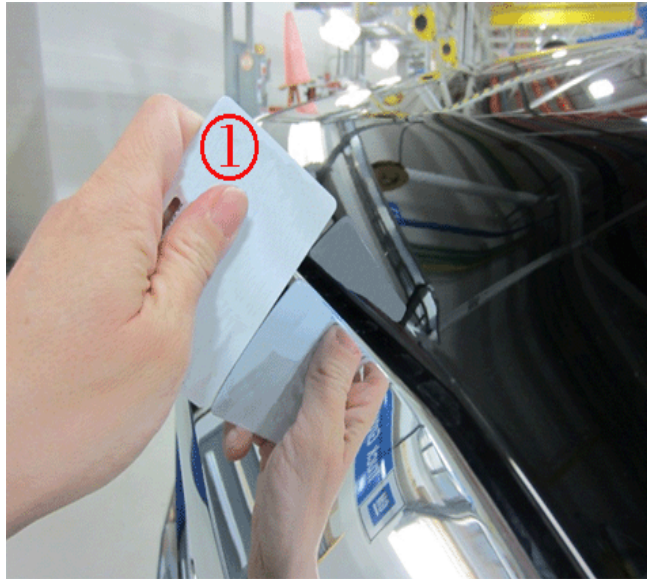
3813277

Check to see if the chrome portion of the grille is sub-flush to the hood, by using a flat edge and placing it on the chrome of the grille. Then slide it up until it reaches the tip of the hood. Perform this check in several spots from left to right. The grille position is correct if the flat edge (1) has to be raised up to sit on the hood as shown in the diagrams and picture below. If the flat edge (1) does not touch the hood, the grille is proud of the hood and will need to be adjusted per the following procedure.
