Service Bulletin

Bulletin No.: 14-08-42-001

Subject: Additional Diagnostic Tips for Headlamp Inoperative or Intermittent Conditions

Models: 2014 Chevrolet Corvette

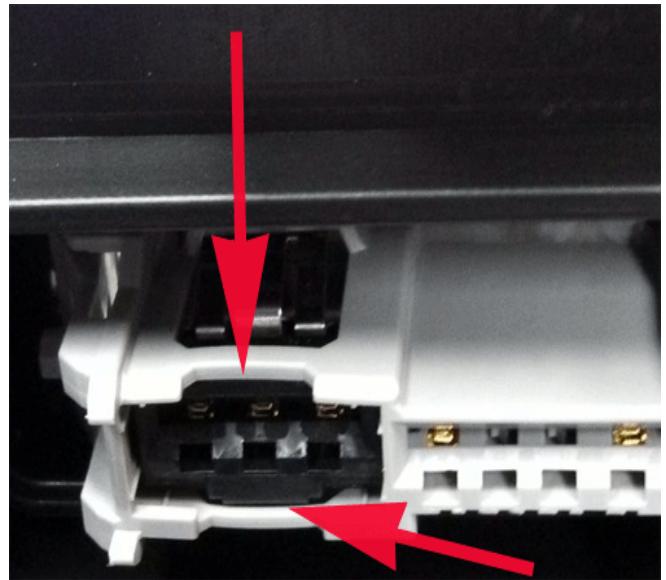
3687135

Incorrect position, HV Cable tabs not fully seated in grey housing (reposition as necessary)

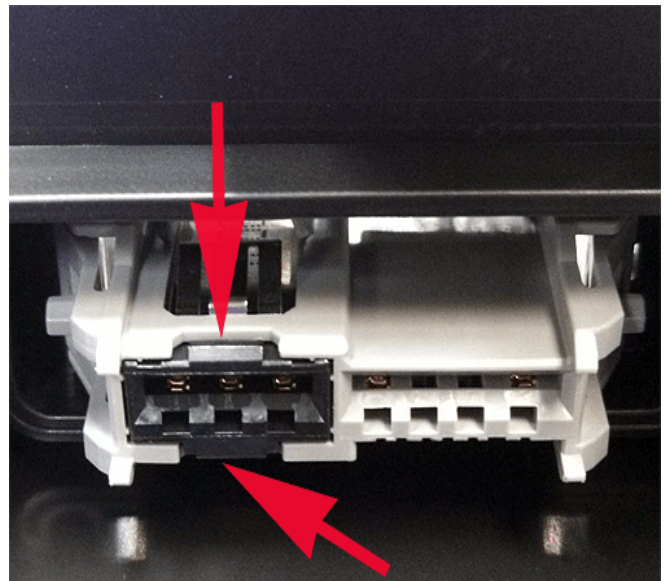
3687132

Correct position, HV Cable tabs seated in grey housing

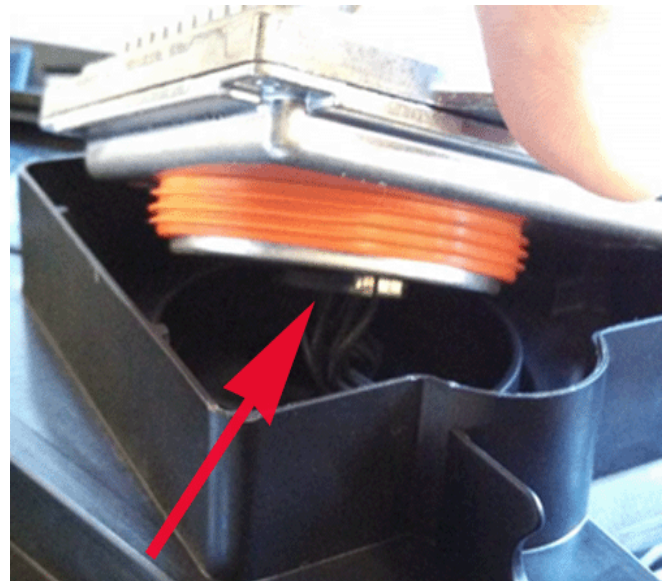
3687151

Visually check if the harness is connected. Slide your fingers between the module and housing to feel if the connection is secured.

11. Reinstall the module, install the three fasteners and tighten to 10.5 in-lbs.
12. Reinstall the affected headlamp assembly. Refer to Headlamp Replacement in SI. Check for operation before installing the related components.
