Service Bulletin

SPECIAL COVERAGE

SUBJECT: Special Coverage Adjustment – Luggage Shade

MODELS: 2013-2014 Chevrolet Trailblazer with RPO VGA

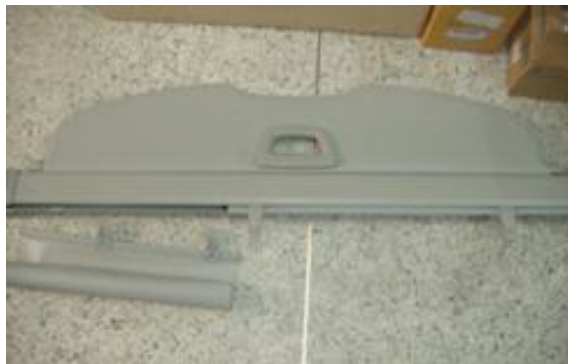
Some 2013-2014 model year Chevrolet Trailblazer may have a condition where the luggage shade may become detached from the roll bar. There may also be a condition where the luggage shade is too short to attach with the 2nd row seat in the most forward position.

PVC becomes detached from luggage blind

Dealers are to replace the luggage shade. This repair will be made at no charge to the customer.

1. Remove the Luggage Shade from the vehicle.
2. Install the new Luggage Shade.

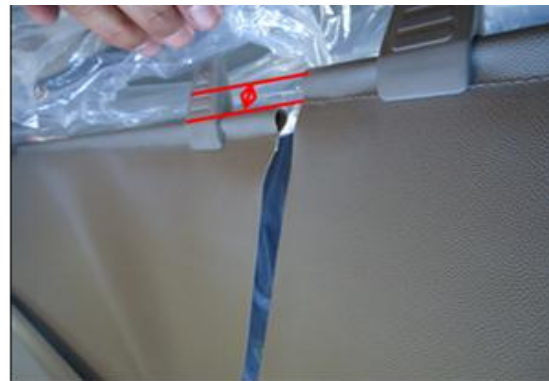
PVC cover short length
