# Program Bulletin

## CUSTOMER SATISFACTION PROGRAM

**SUBJECT:** Tail Lamp Gasket Seal

**MODELS:** 2014 Chevrolet Impala

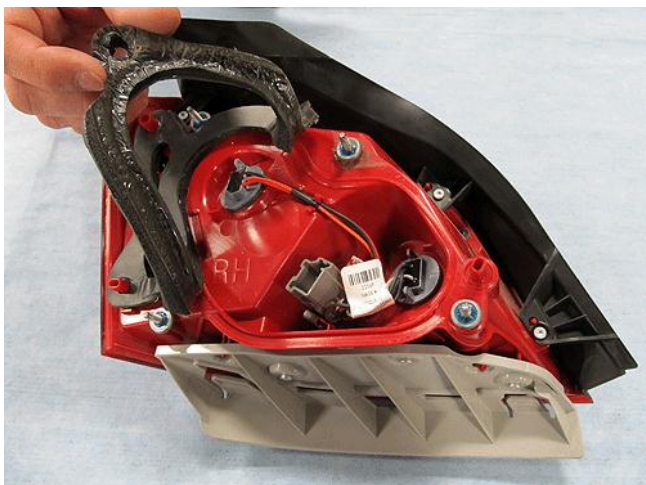
3649621

3. Place the tail lamp assembly on a soft work area to prevent damage to the outer lens area.
