# Service Bulletin

**SUBJECT:** Service Update for Inventory and Customer Vehicles  
Underbody Appearance  
Expires with Base Warranty

**MODELS:** 2014 Chevrolet Silverado 1500  
2014 GMC Sierra 1500

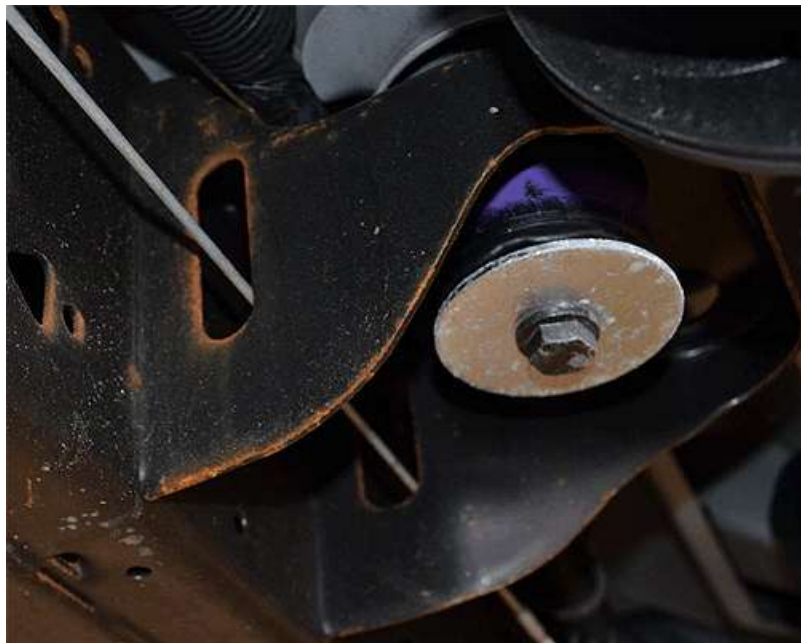
3686508

- Body mounts (visible underneath door(s))

Repair Required

1. Any loose rust or coating should be wire brushed off.
2. Using a rag and general purpose adhesive remover, wipe down the affected repair area.
3. For the front spring mounts, frame and body mounts, apply a coat of Daubert Nox-Rust® P/N X-121B “One Coat Rust Preventative Coating” (aerosol), or equivalent.
4. For the rear axle assembly and rear shock mounts, apply a coat of Lloyds Kryptonite Metal Treatment P/N 36502 Life Long Rust Protection (14 ounce aerosol), or equivalent.

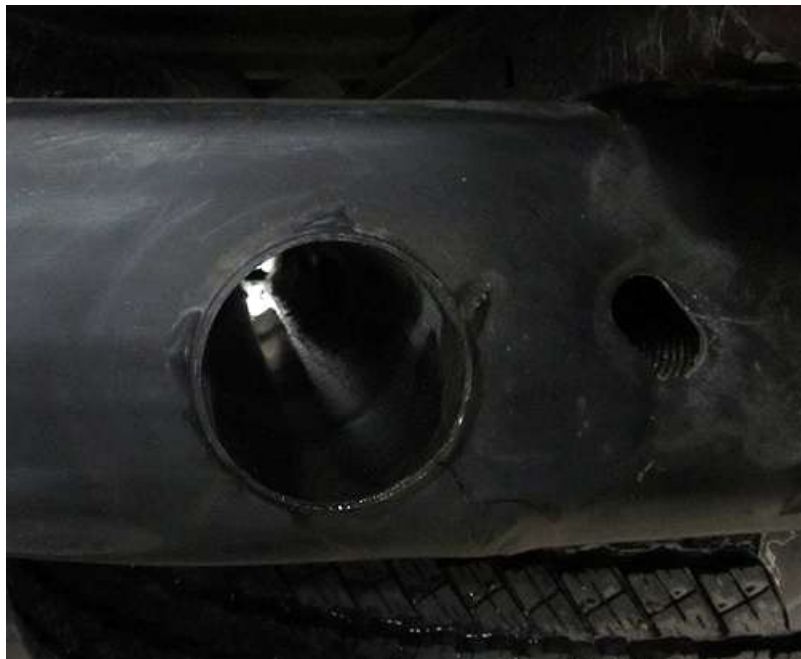
3687198

- Frame and flanges (visible through wheelhouse and underneath door(s))

No Repair Required

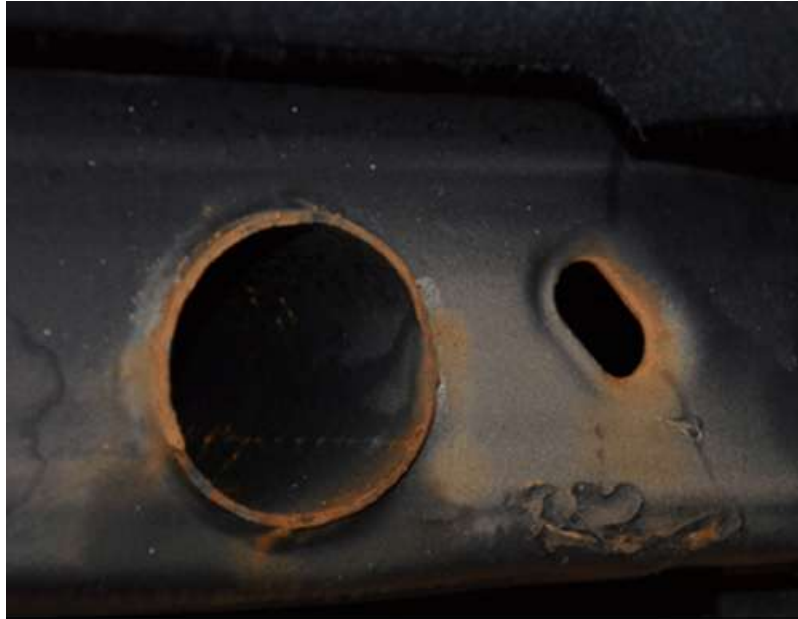
3687196

Repair Required

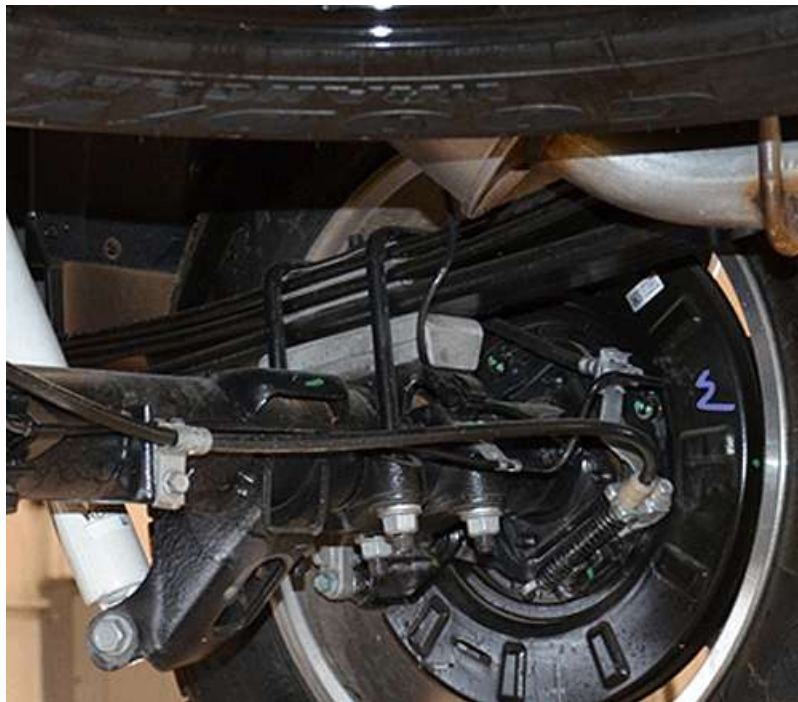
3687935

- Rear shock lower mounts

No Repair Required

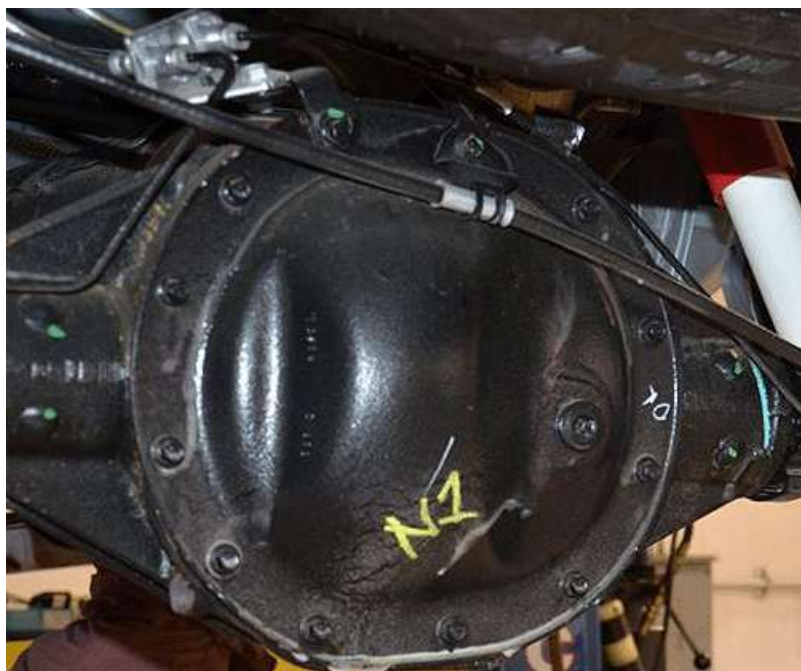
3686527

- Rear axle assembly

No Repair Required
