Service Bulletin

SUBJECT: Service Update for Inventory Vehicles Only
Fuse Block Retention
Expires February 28, 2016

MODELS: 2015 Chevrolet Silverado HD
2015 GMC Sierra HD
Equipped With 220 Amp Generator (KW5)

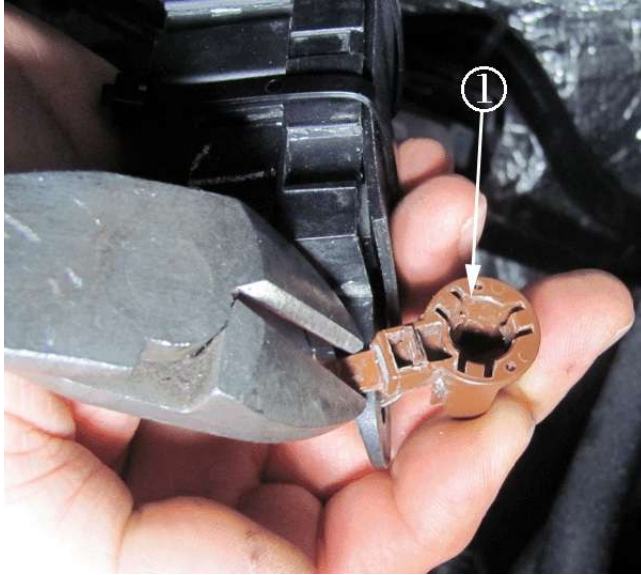
3709042

Note: Review the current orientation of the brown clips (1) on the fuse block. Ensure the black clips are installed in the same orientation as the brown clips were installed.

4. Remove the brown clips (1) from the fuse block using wire cutters or similar tool.
5. Discard the brown clips.
6. Install the black clips onto the fuse block.
