Program Bulletin

CUSTOMER SATISFACTION PROGRAM

SUBJECT: Incorrect Safety Lock Switch

MODELS: 2014 Chevrolet Cruze

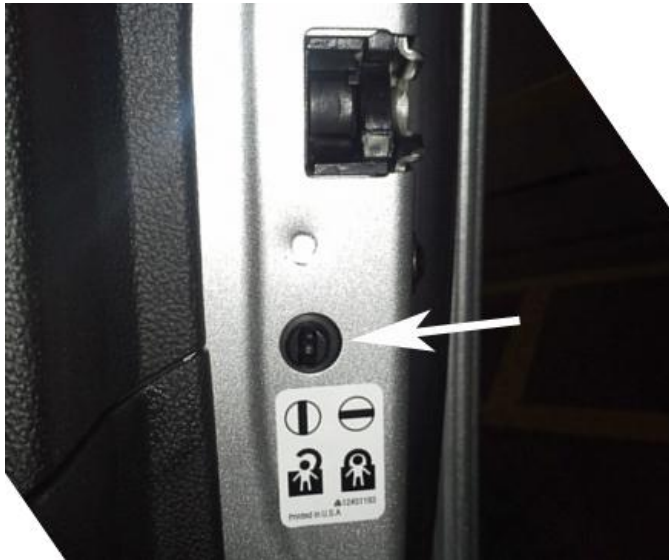
3710169

1. Open either rear door and examine the rear door edge.

2. A manual door safety lock switch and operation sticker should be present as shown above on vehicles within the affected VIN range.

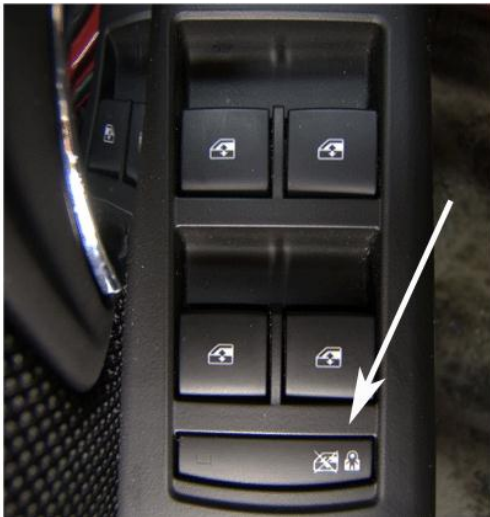
3710187

3. Looking at the driver's door panel power window control, find the lockout switch. If there are two symbols as shown above indicating both rear window lockout and electric rear door safety locks, then the vehicle's switch must be replaced. Refer to the Switch Replacement Procedure below.

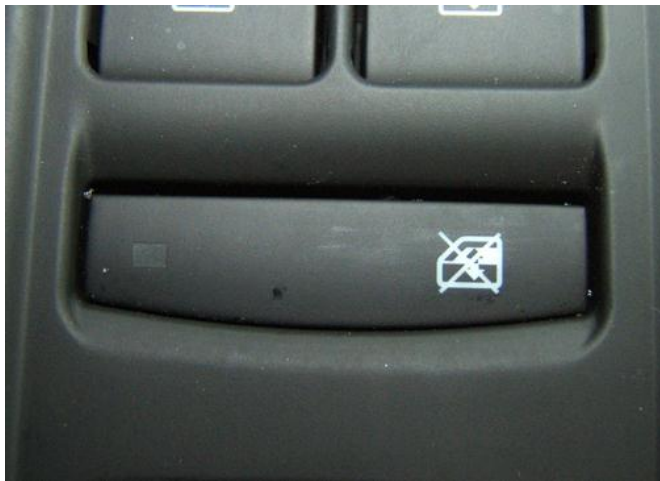
3710189

4. If the lockout switch has only the rear window lockout icon as shown above, then the vehicle has the proper switch installed. No further action is required.

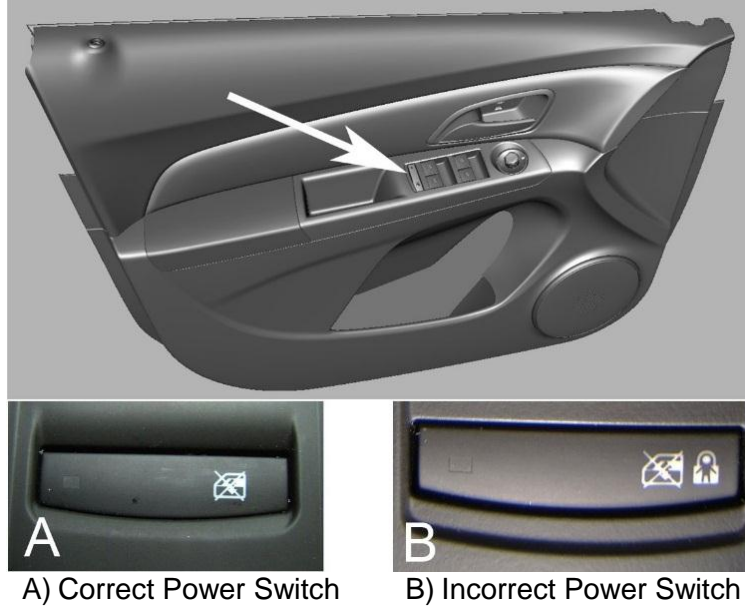
3711802

We have learned that your 2014 model year Chevrolet Cruze may have had an incorrect power switch installed on the driver door. Your vehicle is equipped with manual rear door safety locks; however, the power switch installed on the driver door may include an icon for the electric rear door safety locks.

What We Will Do: Your GM dealer will inspect the power switch on the driver door to ensure that the correct power switch is installed. If your vehicle has an incorrect switch, your dealer will install the correct switch. This service will be performed for you at **no charge until March 31, 2016**. After that, any applicable warranty will apply.

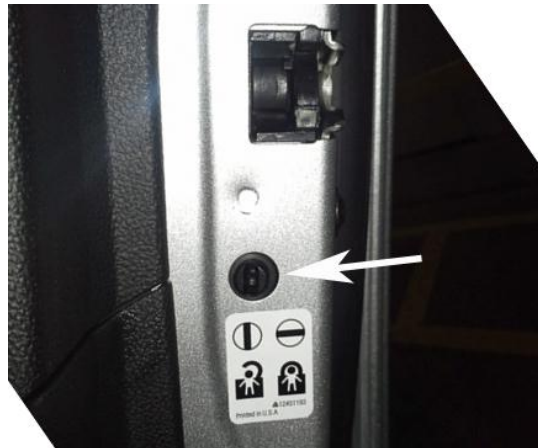
3710169

To engage the rear door safety locks on your vehicle, open either rear door and locate safety lock slot on the edge of the door (see illustration below). Insert your key into the safety lock slot and turn it so that the slot is in the horizontal position. This will need to be repeated on the other rear door lock, as well.
