Program Bulletin

CUSTOMER SATISFACTION PROGRAM

SUBJECT: Front Strut - Noise

MODELS: 2012-2013 Chevrolet Colorado
2013 Chevrolet Trailblazer

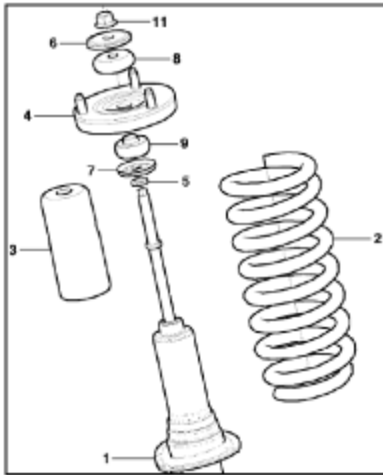
Figure 1

6. Refer to figure 1 - the lower bush (9) will be replaced as well as the spring seat insulator (not shown in figure 1). In addition, inspect the top mount bracket (4), cup washer (7), upper bush (8), and shock absorber rod (1) for damage. Follow these guidelines to determine if these parts should be replaced:

4. Before removing the top mount bracket (refer figure 1, item 4), place alignment marks on the top mount bracket and spring using the outboard mounting bolt on the strut top bracket as a reference. Mark the bottom of the spring to shock absorber as well. These marks should all be aligned as shown in figure 2 and 3.

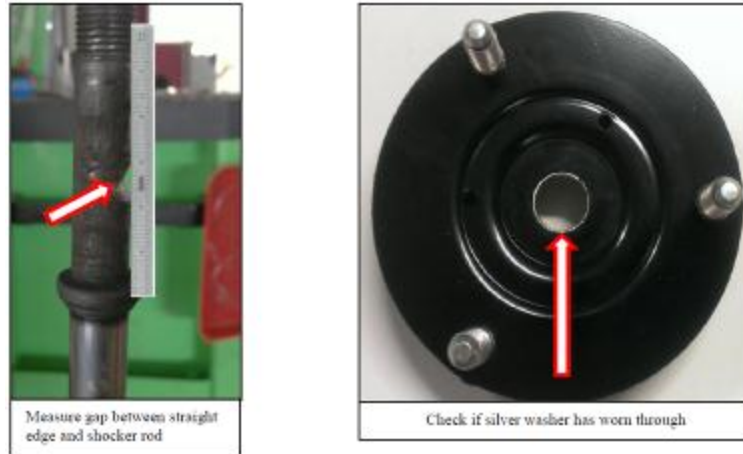
Figure 5 — Check if Silver Washer Has Worn Through

- Inspect the steel washer (silver) that is pressed into the centre of the top mount bracket. If the washer has worn through to the black steel mount bracket, then replace the top mount bracket, refer figure 5.
- Inspect the upper bush (8), if the bush is out of shape or is damaged, replace the bush. In most cases it is expected that the upper bush can be reused. Do not replace it unless necessary.
- Inspect the cup washer (7) for distortion or other damage. Replace only if required.
