# Program Bulletin

## CUSTOMER SATISFACTION PROGRAM

**SUBJECT:** Front Strut Noise Phase II

**MODELS:** 2013 Chevrolet Trailblazer

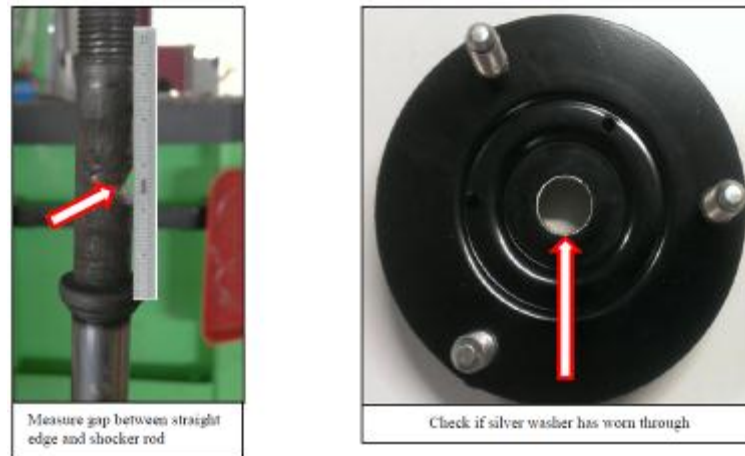
**Figure 4 — Measure Gap between Straight Edge and Shock Rod**

- Place a straight edge along the shocker absorber rod as shown in figure 4.
- Measure the depth of wear on the shaft. If the wear is greater than 1mm, replace the shock absorber.
- Inspect the steel washer (silver) that is pressed into the centre of the top mount bracket. If the washer has worn through to the black steel mount bracket, then replace the top mount bracket, refer figure 5.
- Inspect the upper bush (8), if the bush is out of shape or is damaged, replace the bush. In most cases it is expected that the upper bush can be reused. Do not replace it unless necessary.
- Inspect the cup washer (7) for distortion or other damage. Replace only if required.
