# Program Bulletin

## CUSTOMER SATISFACTION PROGRAM

**SUBJECT:** Incorrect Transmission Thrust Bearing

**MODELS:** 2012 Chevrolet Silverado HD  
2012 GMC Sierra HD  
Equipped with Allison 6-Speed Automatic Transmission (MW7)

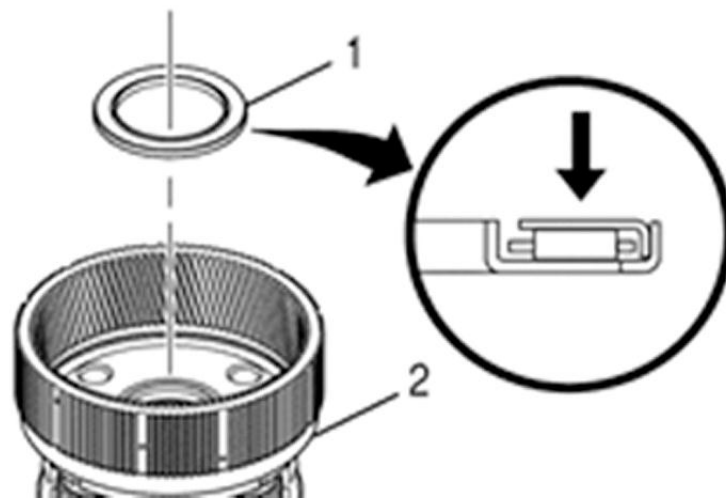
3723744

**Caution:** Installing the thrust bearing incorrectly may cause permanent damage to the transmission.

1. Align the thrust bearing (1) so that the black oxide surface on the thrust bearing is facing up, away from the input carrier module (2).
2. Install the thrust bearing (1) onto the input carrier module (2).
