# Recall Bulletin

## PRODUCT SAFETY RECALL

**SUBJECT:** Brake Booster Pump – Cavity Plug

**MODELS:** 2013 and some 2014 Cadillac XTS

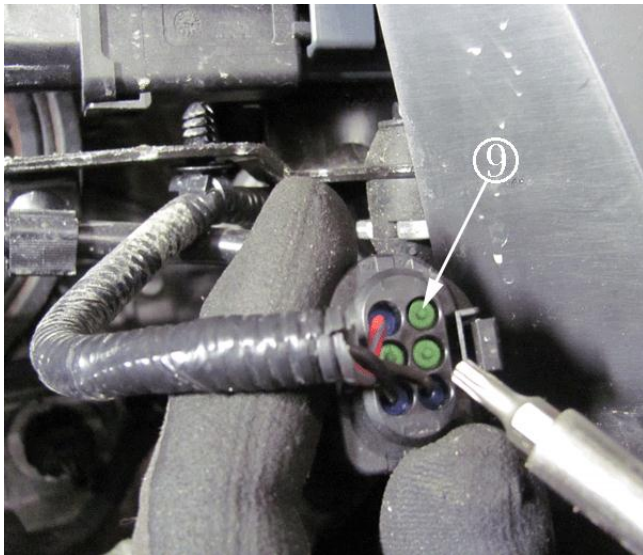
3773742

3. Locate the power brake booster pump electrical connector (7).
4. Disconnect the power brake booster pump electrical connector (7).
5. Inspect the connector for debris and/or corrosion. Clean the connector if required.
6. Determine if three green plugs are installed in the backside of the connector. The green plugs are installed into three of the six cavities on the backside of the connector. Refer to the photograph below.

- If the three green plugs (9) are installed into three of the cavities on the backside of the connector, proceed to step 7.

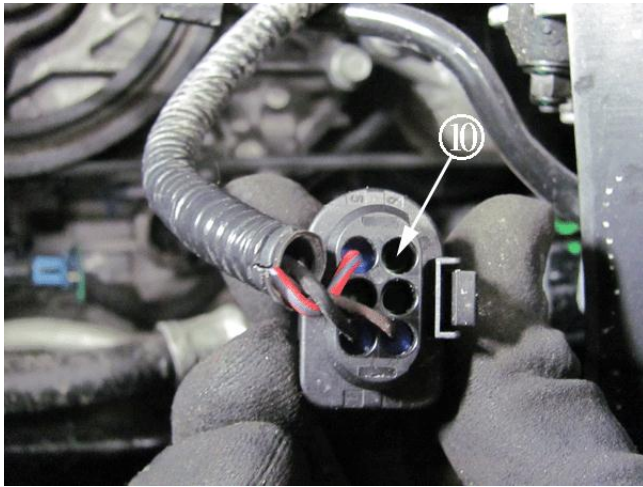
3773733

- Look down into the cavity to determine if a green plug is missing. If any of the three green plugs are missing, replace the forward lamp harness and power brake booster pump. Refer to *Forward Lamp Harness and Power Brake Booster Pump Replacement* in this bulletin.
